in the matter of Submissions and further submissions on the proposed
Waimakariri District Plan
Hearing Stream 12A: Commercial/Industrial, Oxford and
surrounds, Pegasus Resort

Evidence of Matt McLachlan

EVIDENCE OF MATT MCLACHLAN REGARDING 131 MAIN STREET REZONING REQUEST

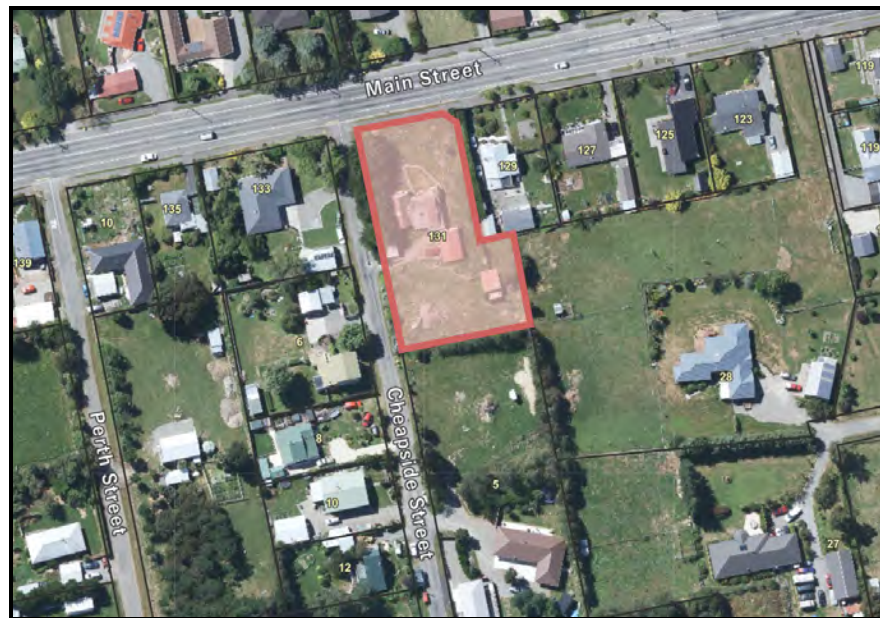
Figure 1: Location Diagram

9. The site is legally described as Lot 1 DP 80871 being 0.2363 hectares in area and located on the southern side of Main Street at the western end of the Oxford township. The site is shown in Figure 1 below.

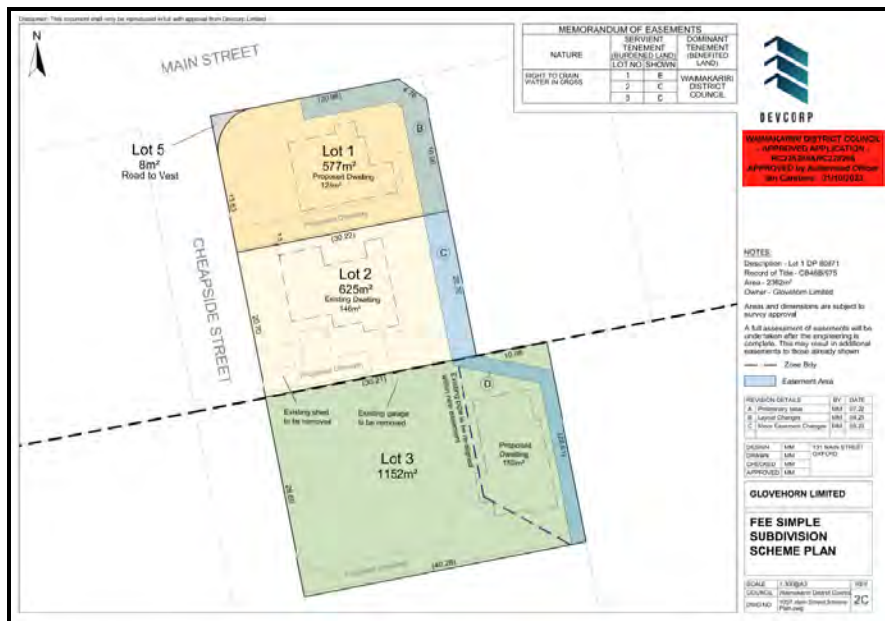
Figure 2: RC225255

12. The surrounding area is residential in nature, characterised by large single storey detached dwellings on medium to large sites with low site coverages.
13. Resource consent (RC225255 / RC225256) for a three-lot subdivision was granted in November 2023 (**ATTACHMENT 1**) and includes:
 - One complying Residential 2 allotment (Lot 2).
 - Two undersized residential allotments – one each in the Residential 2 Zone (Lot 1) and Residential 4A Zone (Lot 3).
 - Corner rounding (Lot 5).
 - Soil remediation on Lot 3.
 - Construction of non-complying vehicle crossing (Lot 1).
 - Relocate a dwelling on undersized residential allotments (Lot 1 and Lot 3).

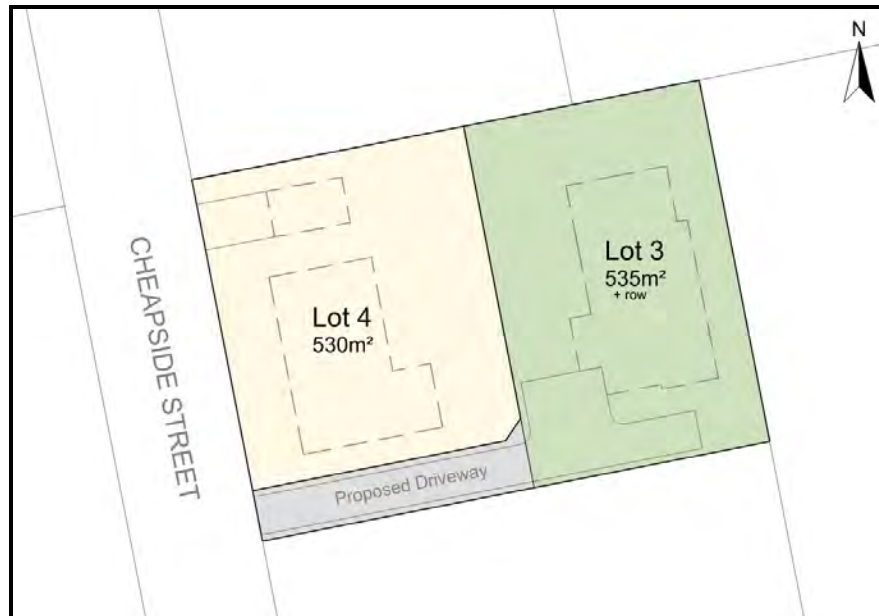
Figure 3: Possible future subdivision of Lot 3 RC225255

rezone the entirety of their property to GRZ, which will allow for one additional residential allotment as shown in Figure 3 below.

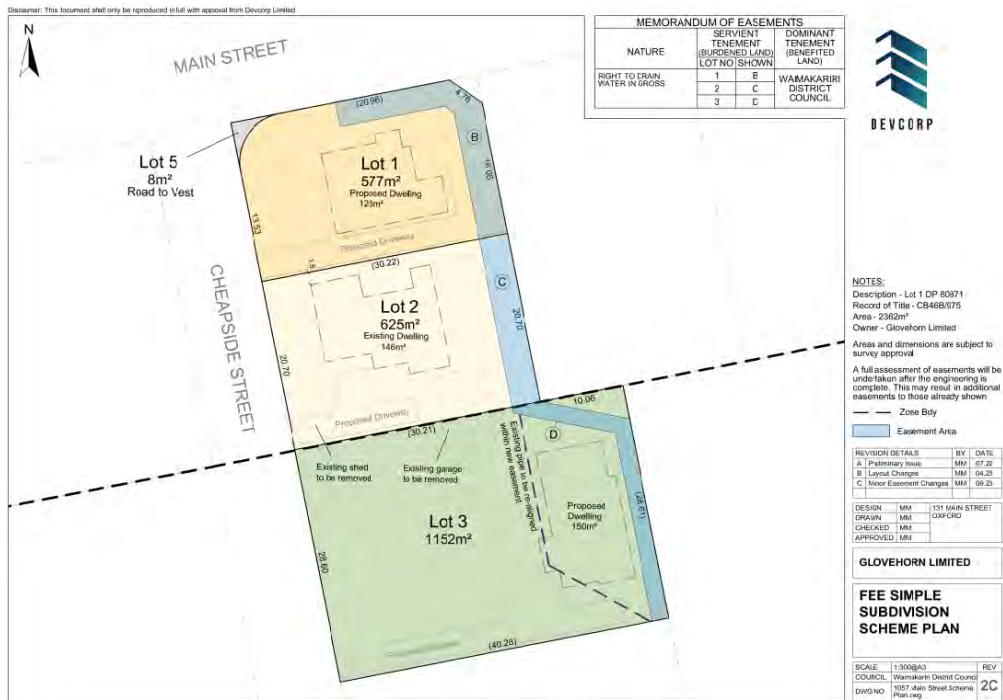
Diagram 1: Proposed Application Plan

- Individual access is proposed to be provided to Lots 1 – 3 from Cheapside Street only and no Right of Ways (shared access) is proposed.
- Services to be provided to water and wastewater reticulation in Cheapside Street, with additional stormwater to be disposed to ground via soakpits.

- Easements in Gross in favour of Council are proposed along the eastern boundary of the site.
- The existing shed and garage on the site are proposed to be removed.

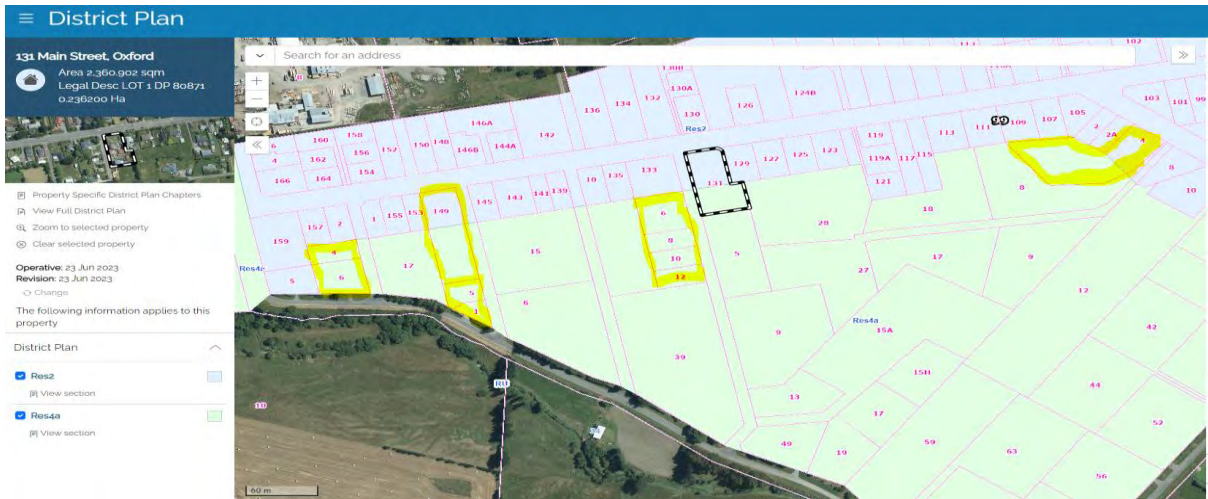
Diagram 3: Operative District Plan zones (Source WDC EPlan)

The site is located in Oxford at 131 Main Street (Lot 1 DP 80871; Record of Title CB46B/975), on the corner of Main Street (to the north) and Cheapside Street (to the west). The site is generally rectangular in shape, as shown in Diagram 2 above, with a total area of 2,362m². The front half of the site is Residential 2 zone, with the rear of the site zoned as Residential 4A zone, as shown below in Diagram 3.

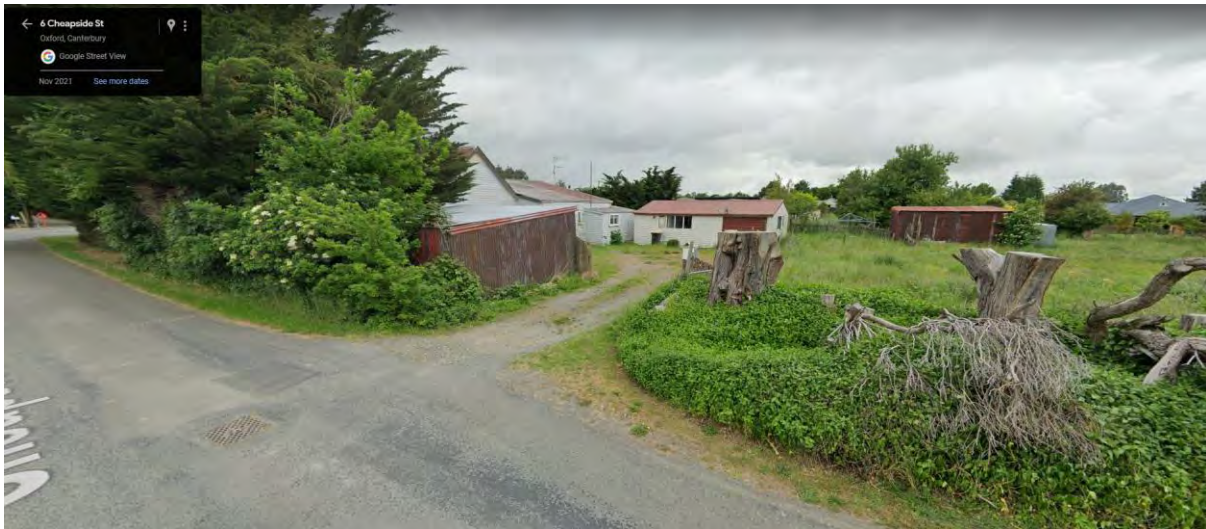
Diagram 6: Cheapside Street existing vehicle entrance

Cheapside Street does not have kerb and channel, nor a formed vehicle entrance crossing to the site.

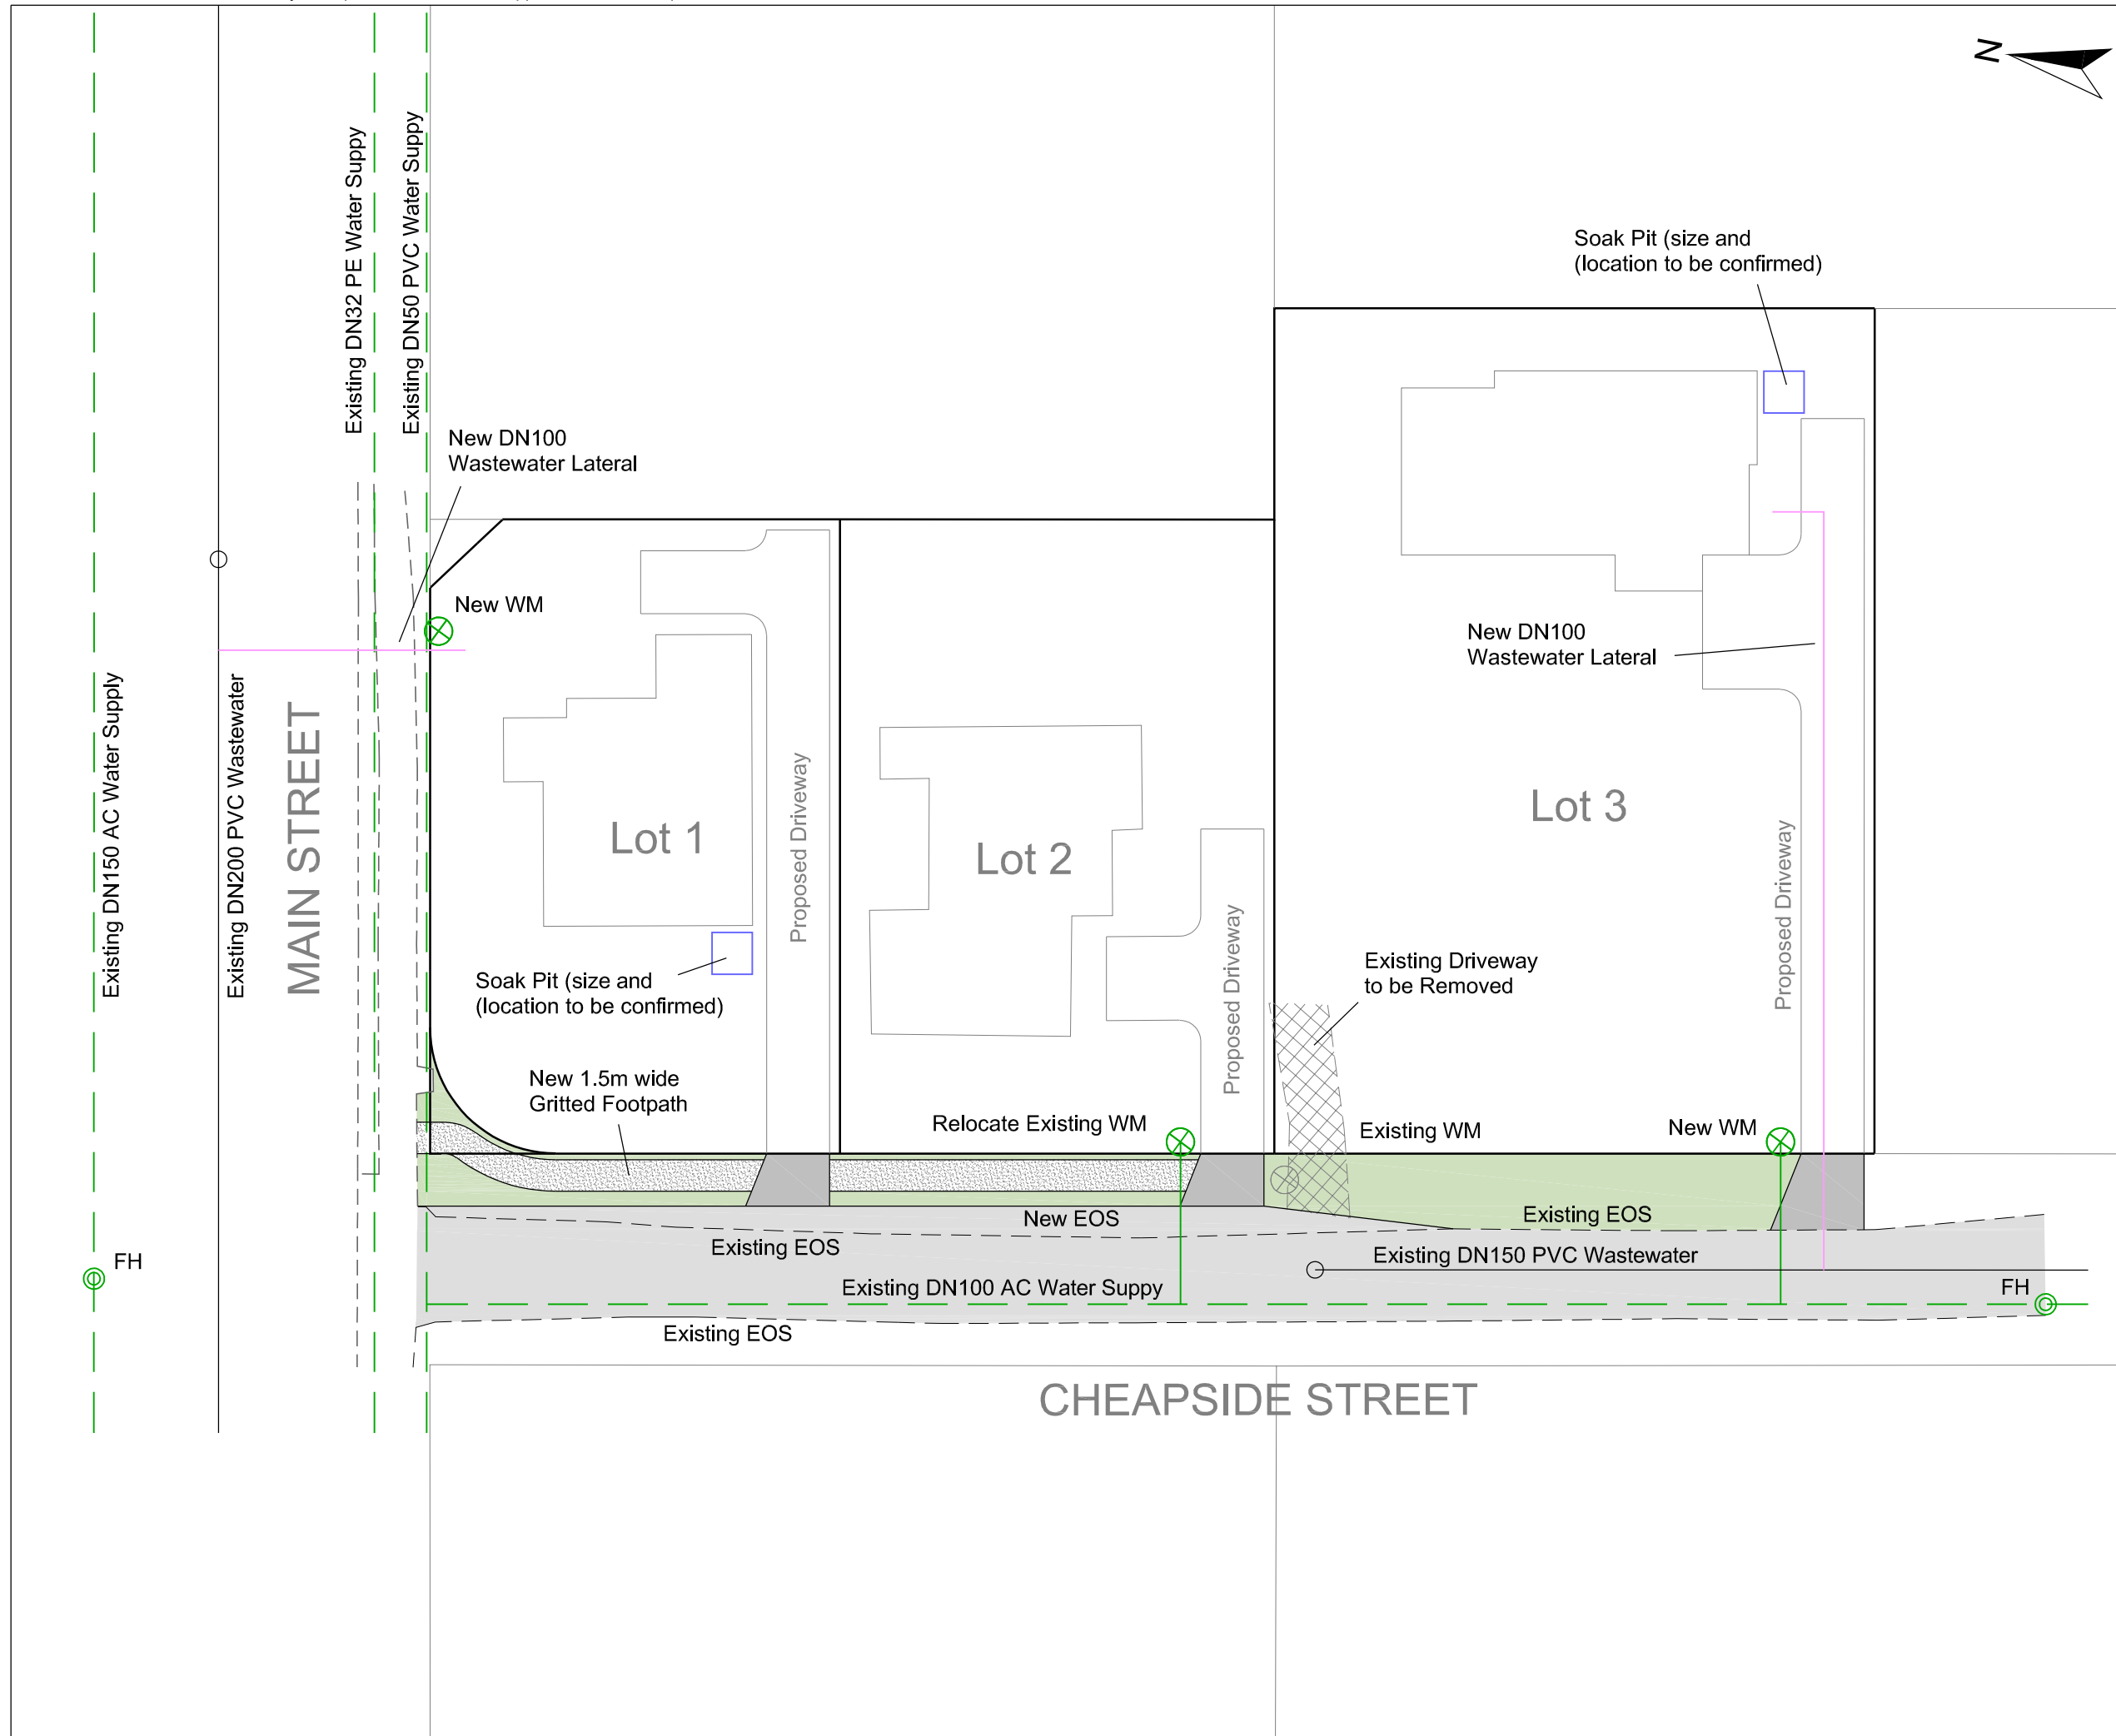
**PRELIMINARY
ENGINEERING PLAN**

SCALE	1:300@A3	REV
COUNCIL	Waimakariri District Council	E2
DWG NO	1057.Main Street.Scheme Plan.dwg

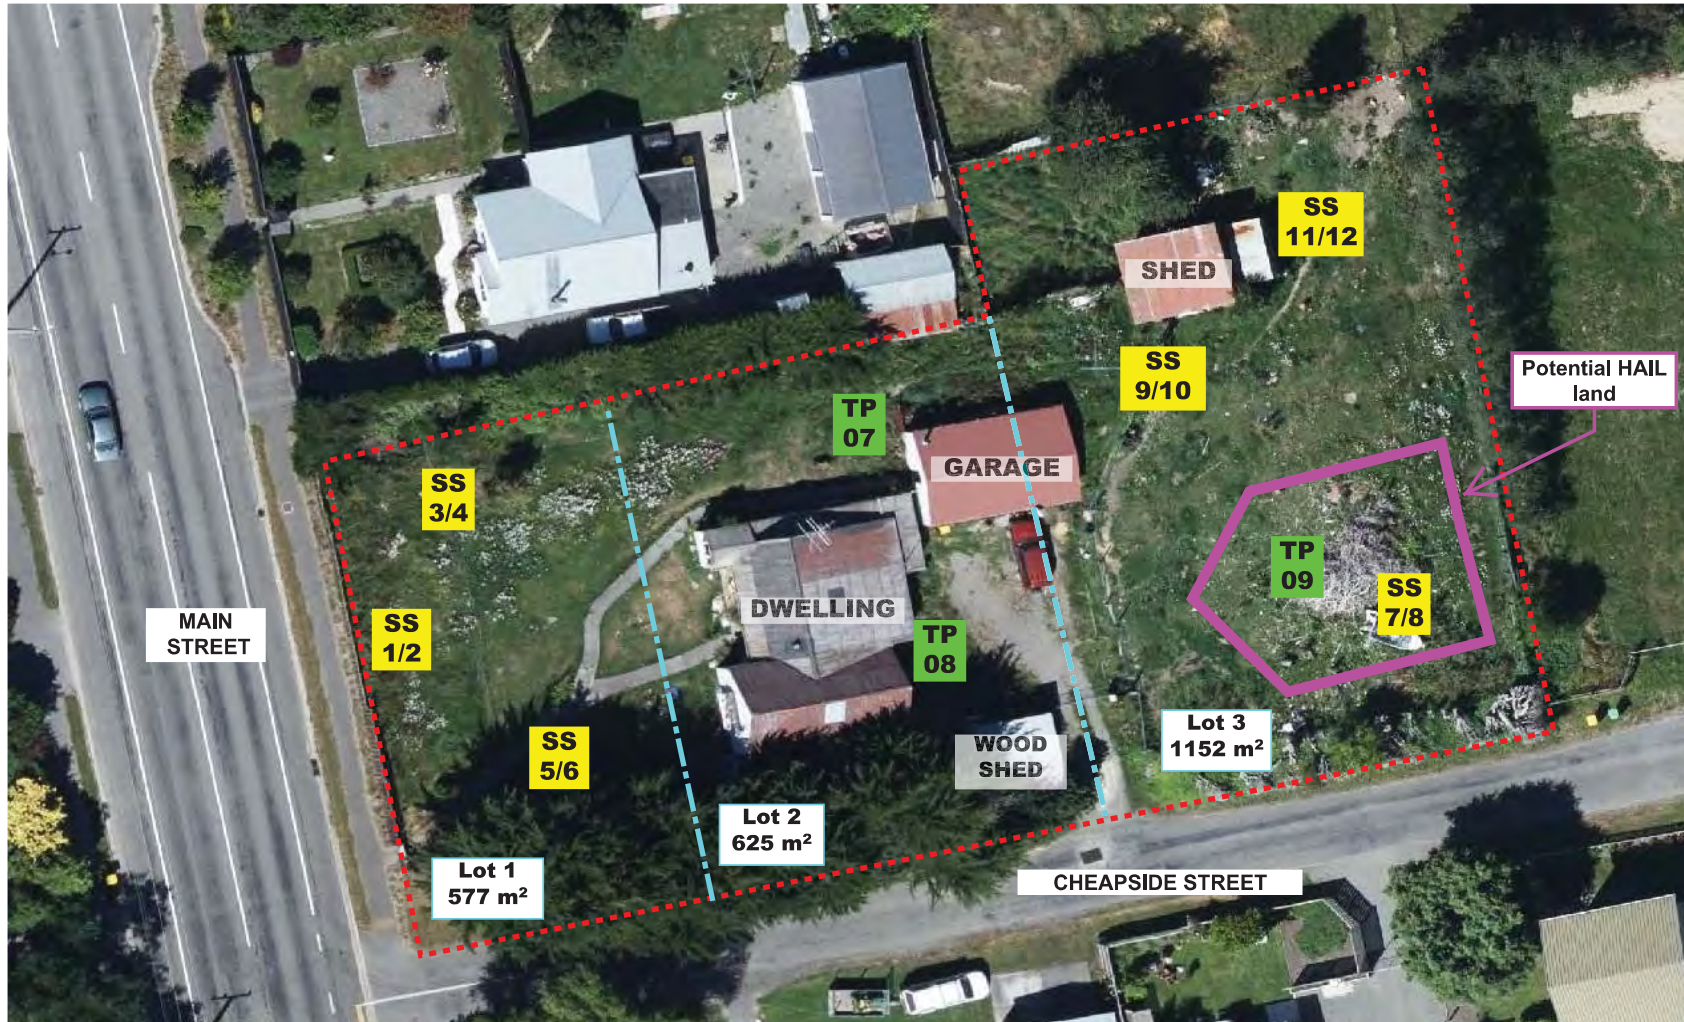
Figure:	2
Project: ZE1023.E02

- TP
xx NZGC Test Pit location
- - - - - Site Boundary
- TP
xx EINZ Test Pit Location:
- - - - - Proposed Subdivision

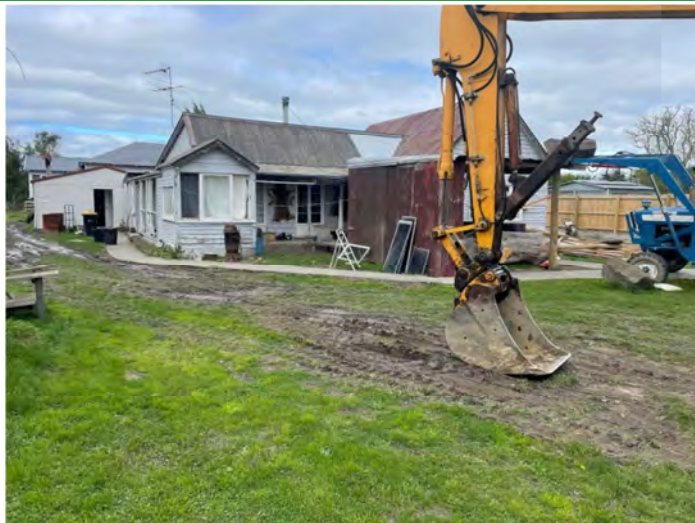
Photo No.2

Existing Dwelling with new fencing being installed in far distance.

Excavator arm shows dimensions of scoop used for test pitting.

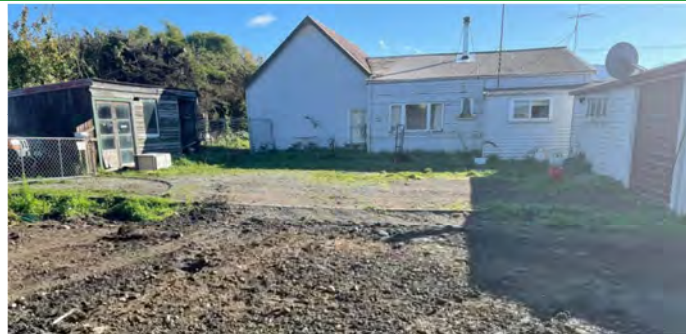
Photo No.3

Rear of dwelling looking north.

Small wood shed observed along western boundary.

Photo taken by NZGC in June 2023, shows western boundary plantings (now removed).

- Behind the house was a timber constructed wood shed and a metallic garage (**Photo 2 and 5**) and a large relocated house stored on raised metal framing (**Photo 3**). Exposed areas of the site are generally covered with grass, soil and gravel.

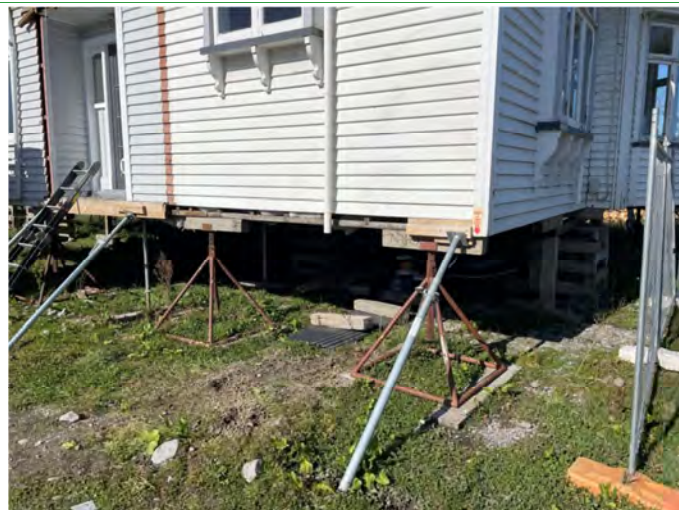
Relocatable home in southern part of property.

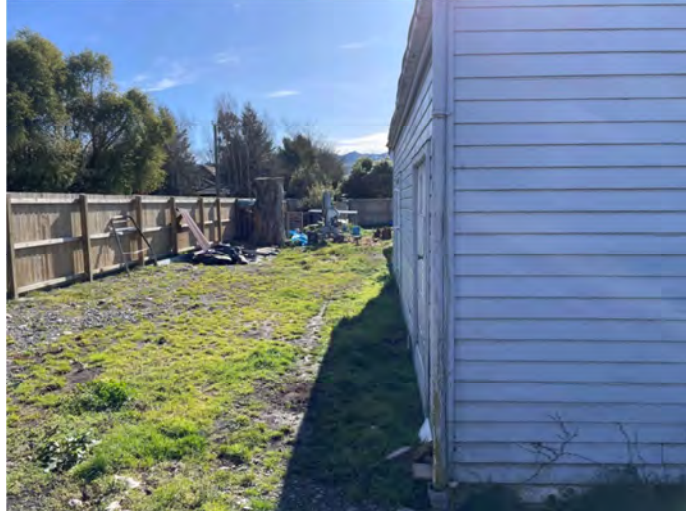
Photo No.5

Current eastern site boundary looking north, showing TP08 location

NZGC sample locations SS1 & 2 in far distance.

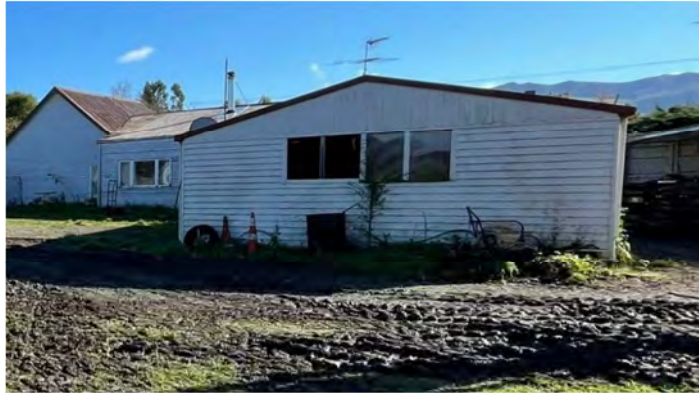
Photo No.6

Rear garage

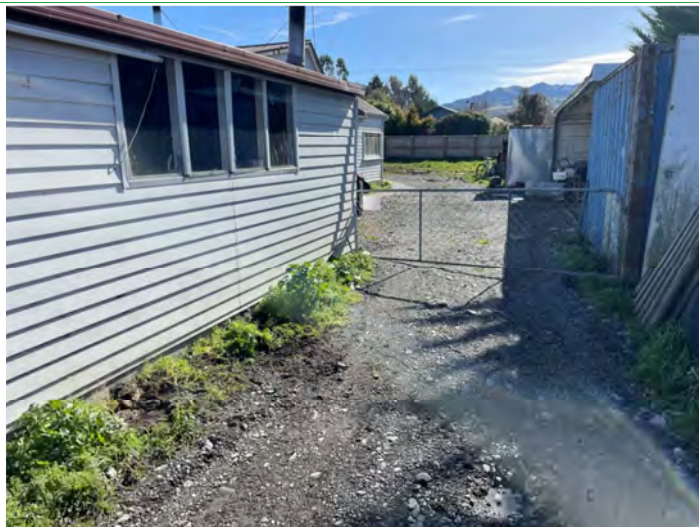
Rear garage, eastern boundary looking north.
TP07 in distance, with tool shed along eastern boundary

- A storage container storing tools was present along the western boundary (**Photo 6**) and a second metallic structure containing firewood was present to the north of the storage container (**Photo 7**). No significant chemical storage was observed.

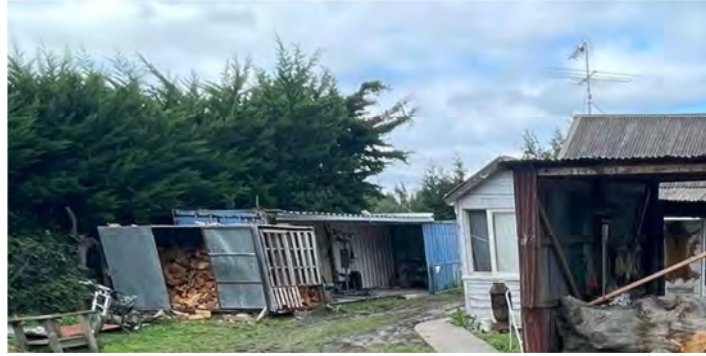
Photo No.8

Tool shed along eastern boundary,
looking south

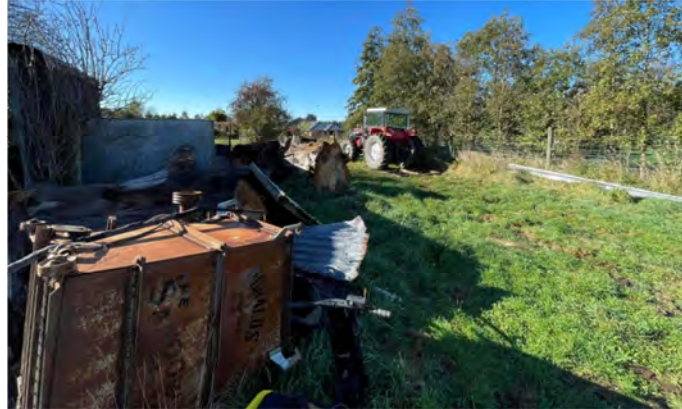
Photo No.9

Rear boundary looking east.

- Further storage containers and machinery was stored in the south western corner of the property (**Photo 8**).
- No significant waste piles or evidence of significant deposition to land activities was observed, and the vegetation did not show signs of distress. Soil was generally undisturbed in the advanced test pits, with the typical soil profile encountered in **Photo 9**.

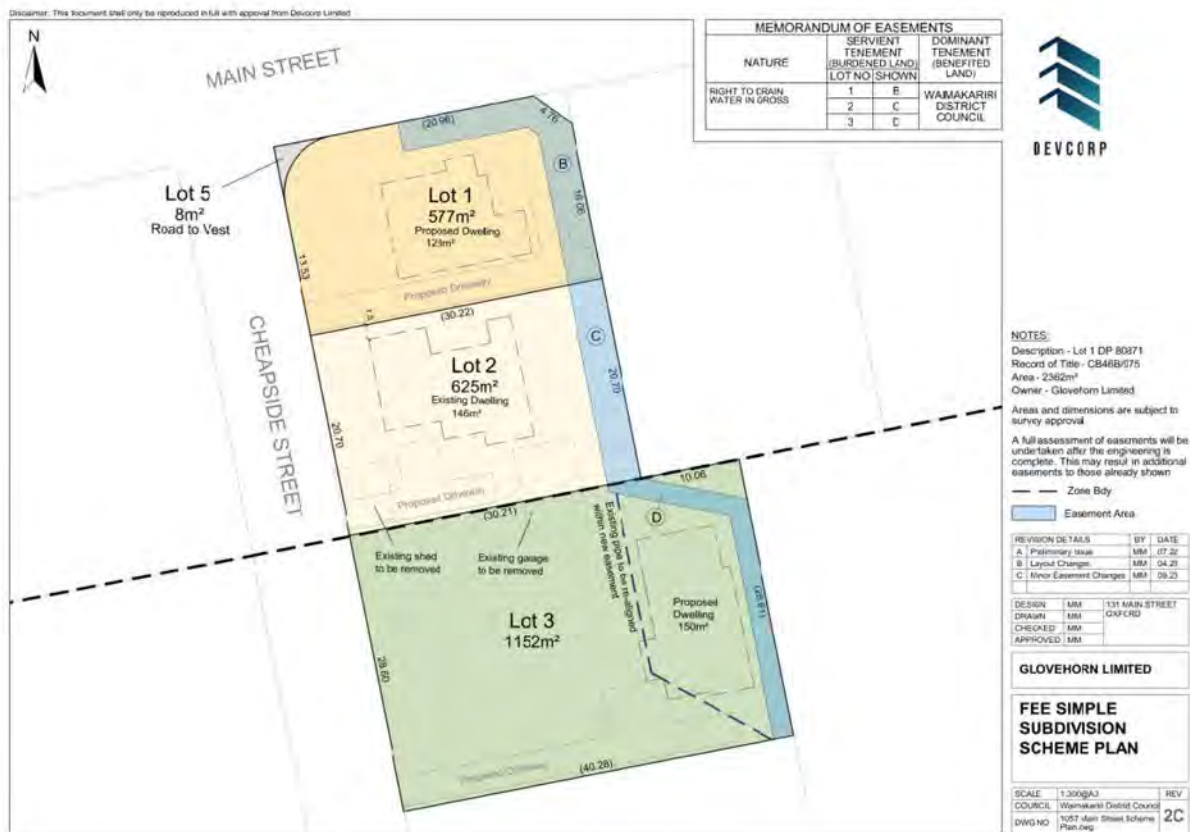
Figure 1 Proposed Subdivision Plan

As indicated by the plan, the subdivision will remove the south eastern shed to create three individual property titles which incorporate:

- The relocation of a residential dwelling at Lot 1, covering 577 m² in the northern part of site, fronting Main Street;
- The retention of the existing dwelling and garage at Lot 2, covering 625 m² in the central part;
- The relocation of a residential dwelling in the eastern part of Lot 3, covering 1152 m² across the southern third of the site; and
- The installation of a vehicle crossing in Lot 1 from Main Street, and adjoining driveways along the eastern boundaries of Lots 2 and 3.
