WAIMAKARIRI
DISTRICT COUNCIL

Utilities and Roading Committee

Agenda

Tuesday 21 June 2022

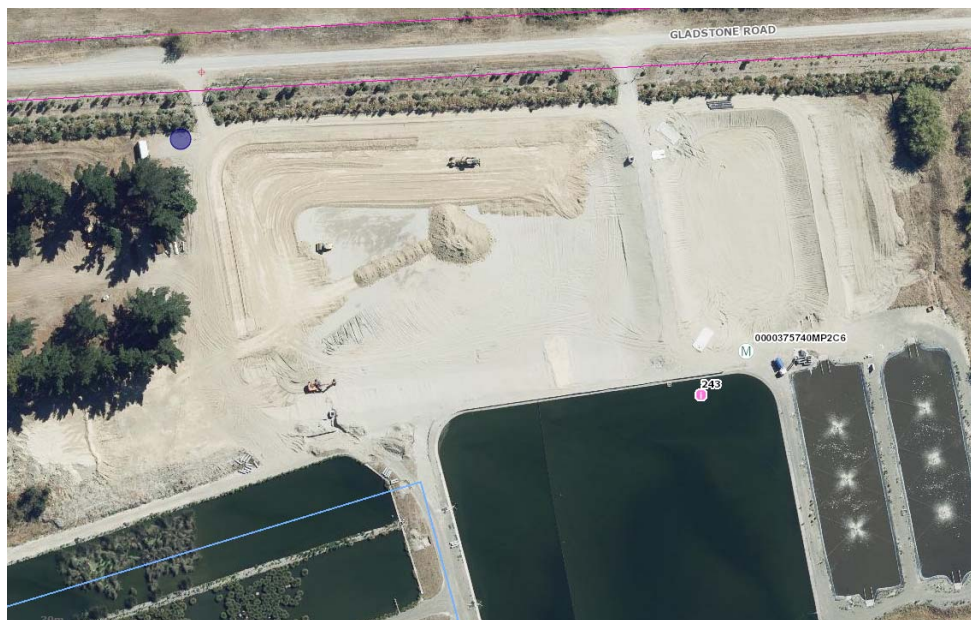
Figure 4: Recommended location of waste disposal bin location (purple dot) at Woodend Wastewater Treatment Plant, near the entrance gate for ease of collection.

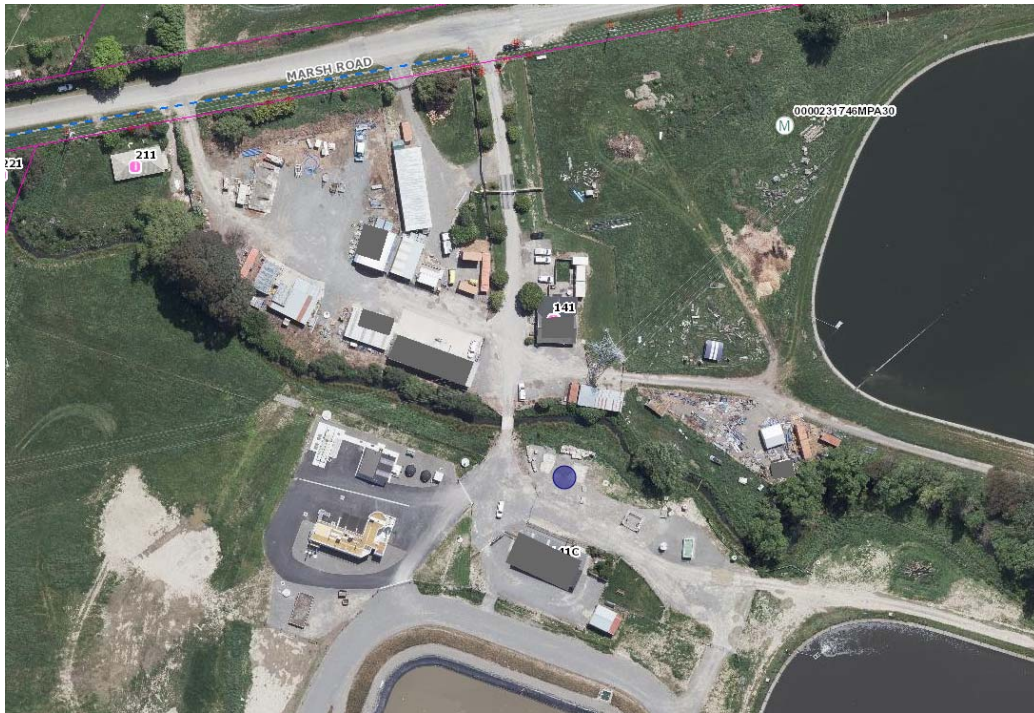
Figure 5: Recommended location of waste disposal bin location (purple dot) at Rangiora Wastewater Treatment Plant.

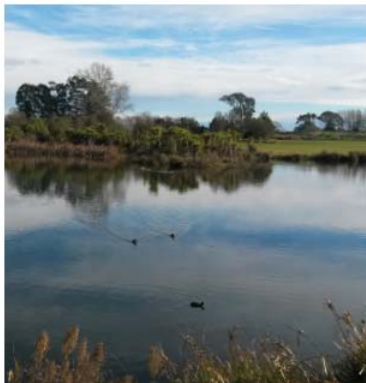
The majority of outbreaks are caused by ducks eating maggots that have fed off dead birds. This diagram illustrates the lifecycle of the disease.

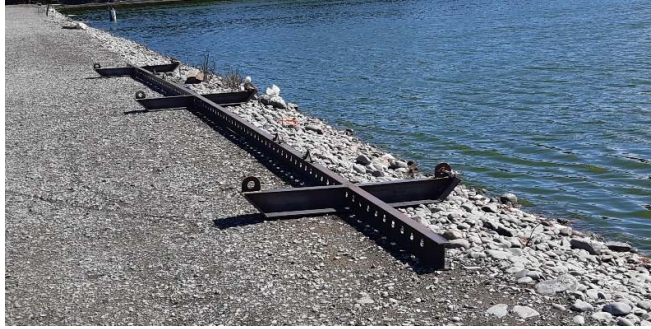
Figure 1: The dredge that has been designed by 3 Waters staff for use at Kaiapoi WWTP, and nicknamed the ‘the Midge-buster’

- 4.3. Dredging of sediment has been successfully trialled by Christchurch City Council at Bromley WWTP. Due to a greater depth, a jet boat is used at Bromley WWTP to pull the dredge. Due to a shallower depth at Kaiapoi WWTP wetlands an excavator is used. Figure 1 shows the midge dredge that is used within the wetlands at Kaiapoi WWTP to stir up the bed, resulting in drowning of the midge larvae who lose their breathing tubes.

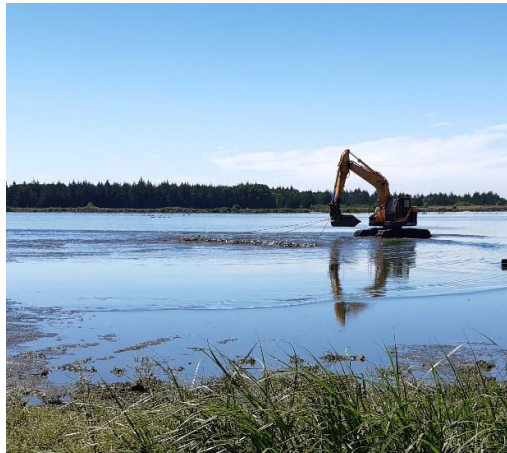
Figure 2: Larval disruption dredging in action, otherwise known as ‘midge-busting’

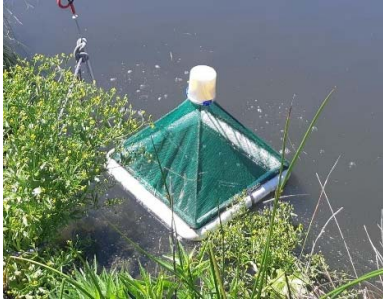
Figure 3: A midge emergence trap

- 4.16. Two midge emergence traps were placed at Woodend WWTP for the first time in the 2021-22 season. Due to the inability to prevent the spread of the oil over the entire surface of the wetland, and the low number of traps, no midge traps are in a 'control' area to compare what happens if oil is not applied.

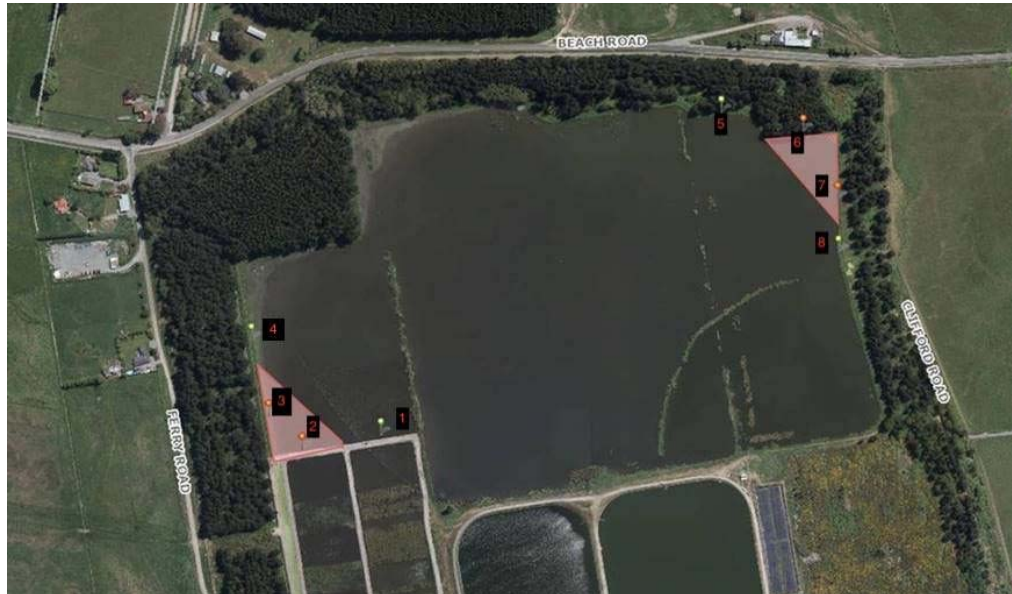
Figure 4: Midge emergence trap locations of the eight traps at Kaiapoi Wastewater Treatment Plant. Pink areas indicate the proposed 'no-dredge' control areas, however 'dredged' treatment areas and 'no-dredge' control areas were not followed by contractors until midway through the 2021-22 season.

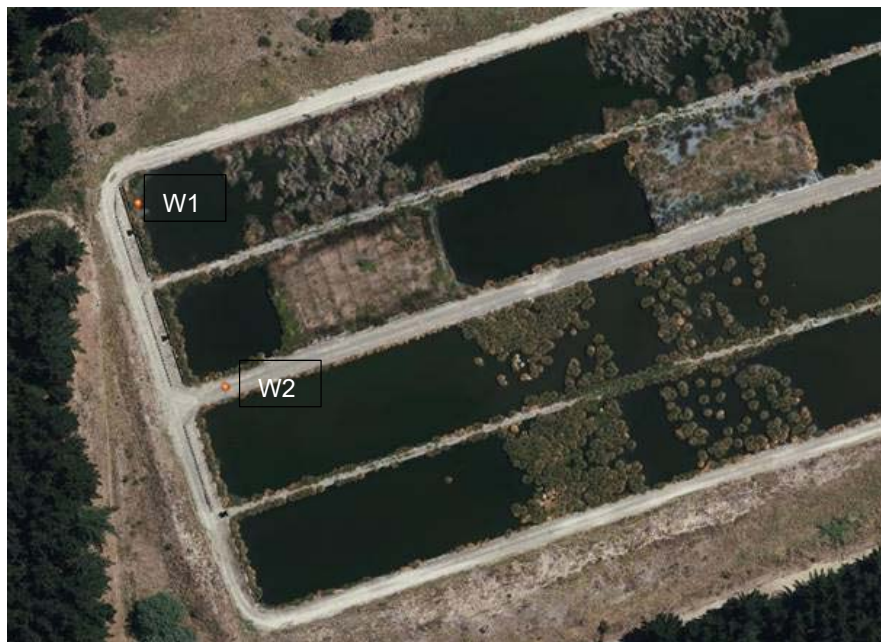
Figure 5: Midge emergence trap locations (red pins) of the two traps at Woodend Wastewater Treatment Plant during the summer and autumn of 2021-22.

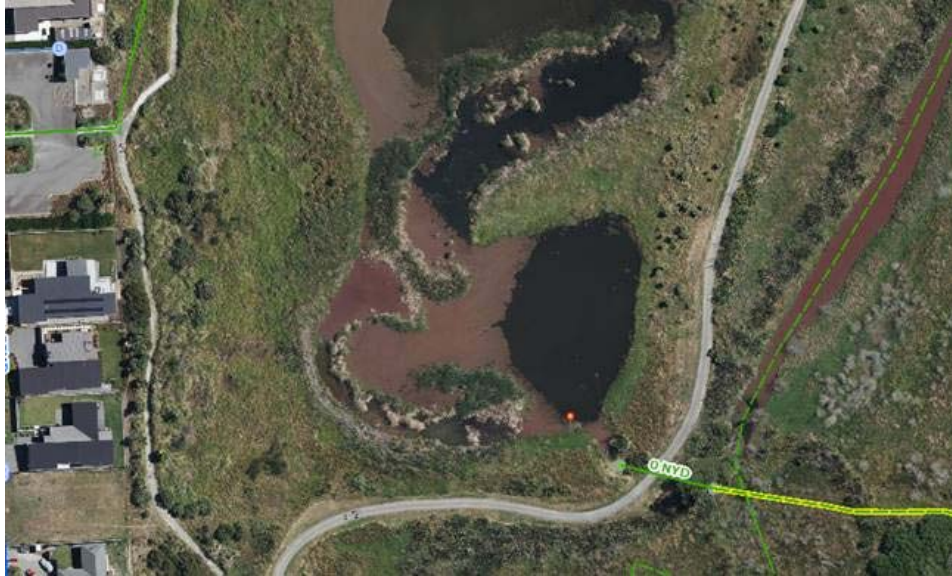
Figure 6: The site (red pin) within the Pegasus Eastern Conservation Management Area accessed from the end of Gladstone Road (ECMA) that was temporarily trapped in 2021-22 to provide wider context of insect emergence from waterbodies in the Woodend area.

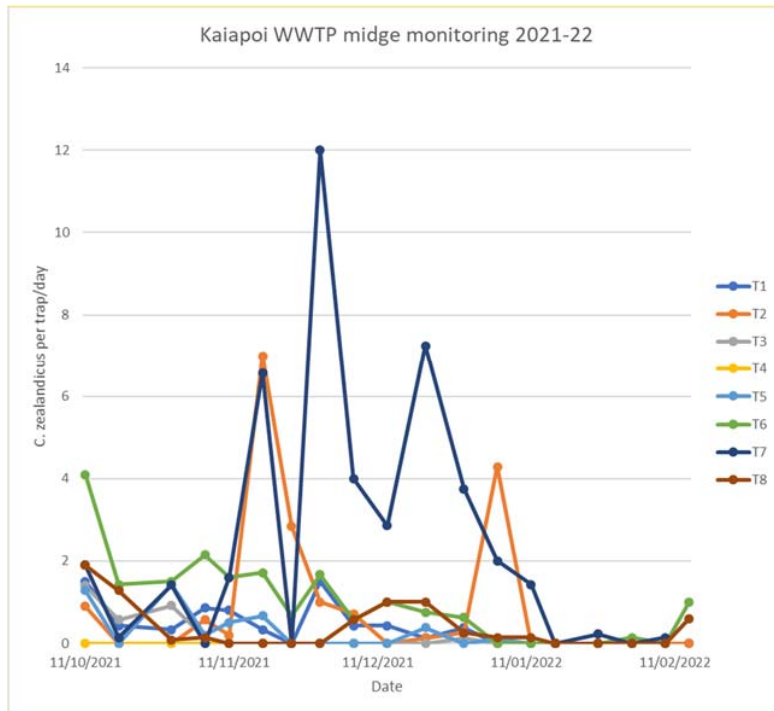
Figure 7: Midge emergence trap data for the eight traps at Kaiapoi WWTP, averaged to catch rates per day (from TRIM 220526086500)

- 4.22. Dates when larval disruption dredging was carried out at Kaiapoi WWTP were: 12/11/2021, 26/11/2021, 10/12/2021, 21/12/2021 and 24/01/2022.
- 4.23. Dates when oil surfactant was applied at Woodend WWTP were: 30/11/2021, 21/12/2021, and 15/03/2022.

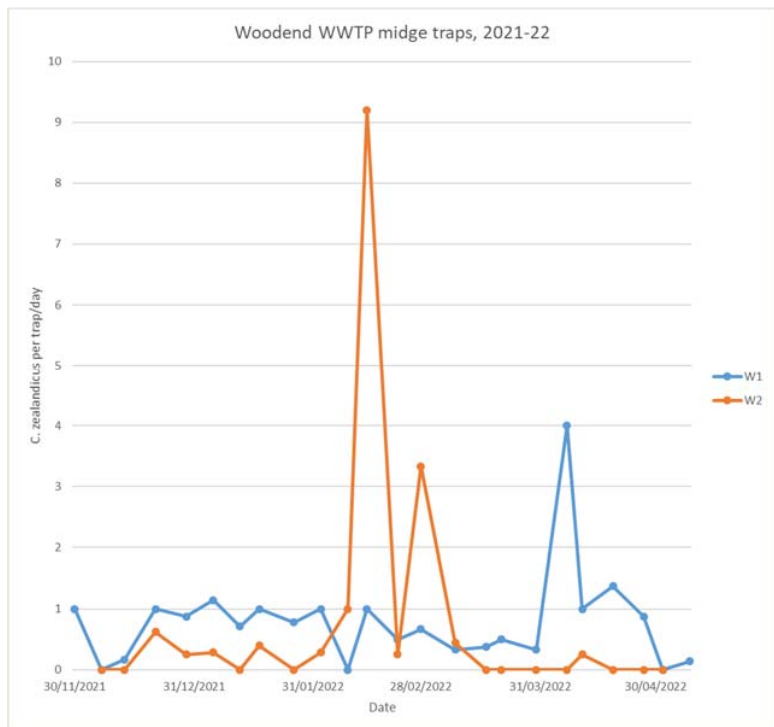
Figure 8: Midge emerge trap data for the two traps at Woodend WWTP, averaged to catch rates per day (from TRIM 220526086499)

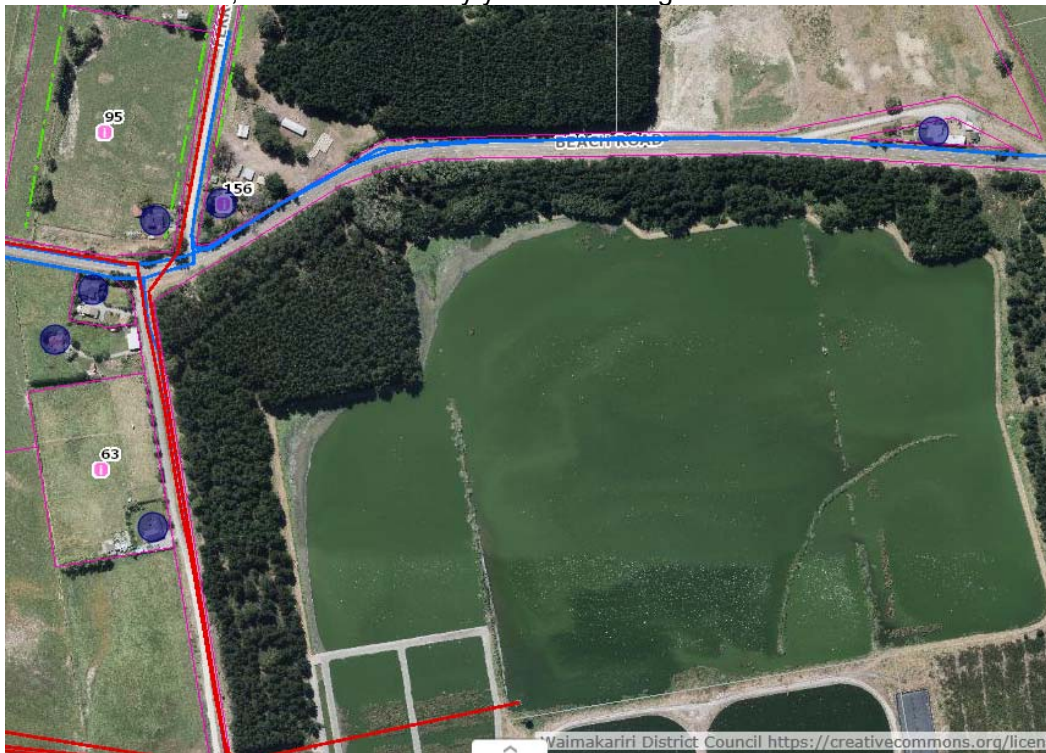
Map 2: The six residences possibly affected by midges near the Kaiapoi WWTP.

Small modifications to six residences within close proximity to the WWTP are recommended (see Map 2). These are recommended to be funded by WDC, rather than the private landowner.

- a. Installation of light-reducing curtains and blinds.
- b. Exterior surface painting from a light colour to a dark colour (reference)
- c. Lightbulb replacement for any bright white lights outside, or inside if visible from the outside, to a lower intensity yellow or red light.

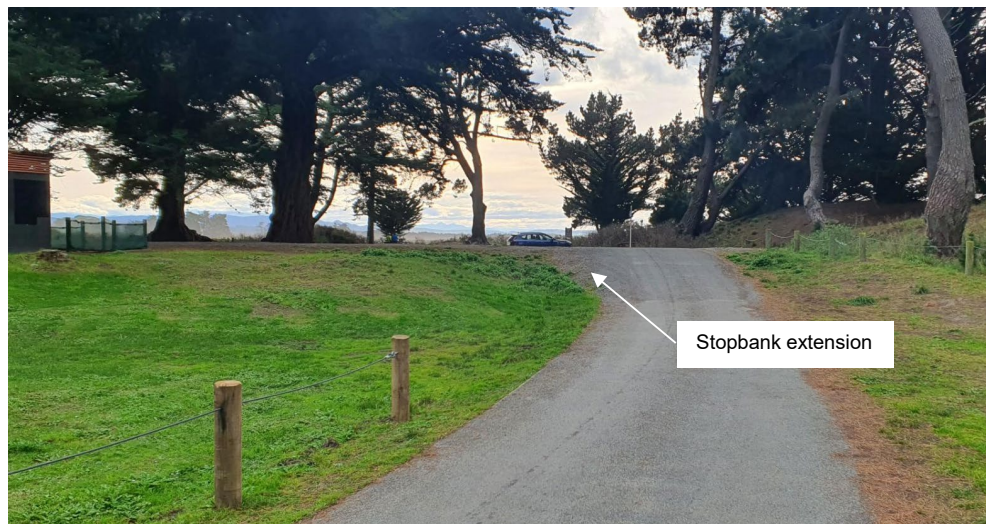
Figure 1 – Photograph of stopbank extension where flow occurred in the May 2021 event

- 4.2. Flooding of the Waikuku Beach Campground occurred in the May 2021 storm event as a result of the Ashley River breaching the lower part of the stopbank (refer Attachment i).
- 4.3. Environment Canterbury have undertaken emergency works to extend the lower reaches of the Ashley River stopbank through to the sand dunes. This work was completed in August 2021. A photograph of the completed works is shown in Figure 1 and Figure 2 below.

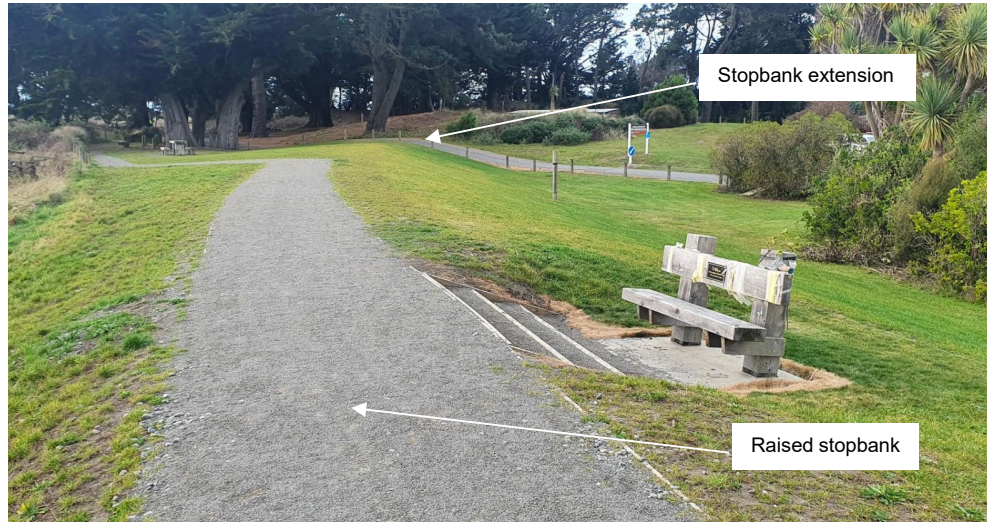
Figure 2 – Photograph of modified stopbank at the Ashley-Rakahuri River Mouth reserve entrance

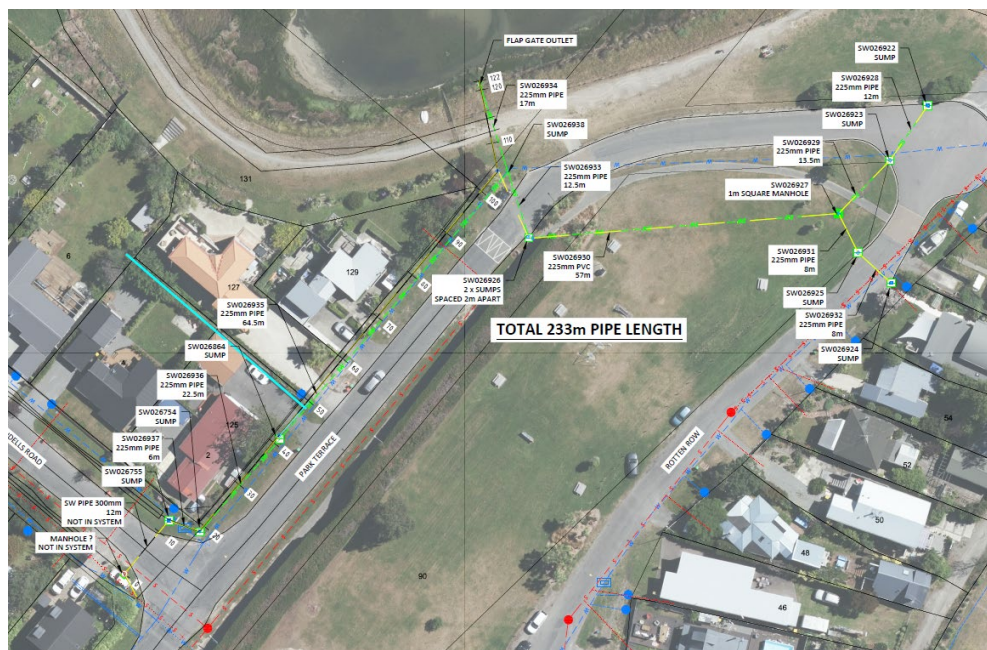
Figure 3 – Pipework CCTV inspected in the Swindells Road / Park Terrace area

- 4.5. Flooding in Swindells Road has been experienced in the May 2021, December 2021 and February 2022 storm events. It is noted that flooding was also previously experienced during the February 2018 event and maintenance works was undertaken in April 2019 to improve flow through the swales and driveway culverts (refer Attachment i).
- 4.6. Since the most recent events, maintenance works to clean pipes in Park Terrace and driveway culverts in Swindells Road has been undertaken. This has included jetting and CCTV inspection of approximately 300m of pipework as shown in Figure 3 below.

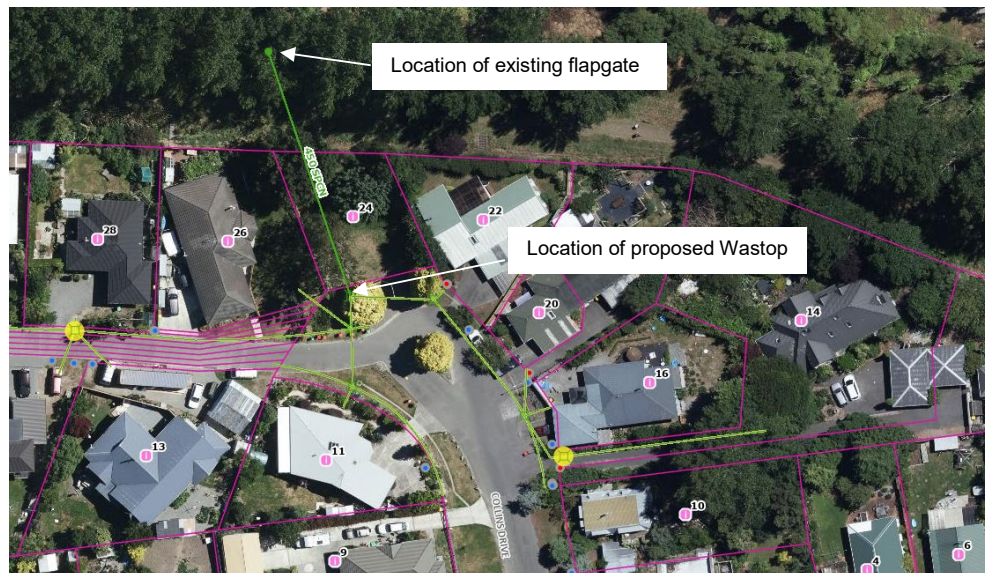
Figure 5 – Location of proposed Wastop valve in Collins Drive

- 4.17. Flooding occurred in Collins Drive during the May 2021 storm event as a result of backflow from the Ashley River bypassing the existing flapgate (refer Attachment i). Maintenance works have been undertaken to improve the operation of the existing flapgate, which is owned by Environment Canterbury. However a secondary flapgate is considered necessary to prevent backflow if the existing flapgate fails in the future.
- 4.18. It is proposed to install a Wastop valve in the upstream manhole in Collins Drive (refer Figure 5 below).

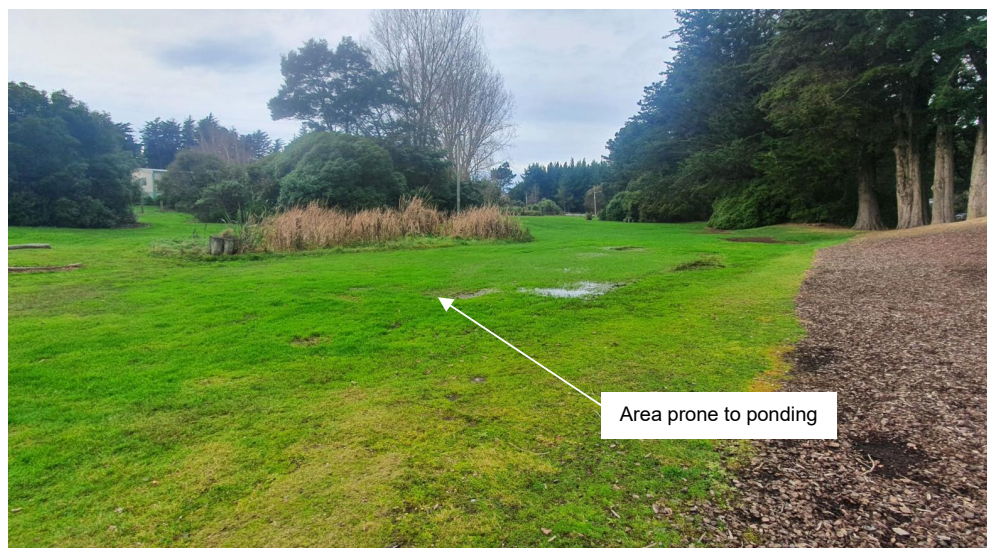
Figure 7 – Area prone to ponding adjacent to the flying fox in the Waikuku Beach Domain

- 4.23. An area of the Waikuku Beach Domain near the flying fox can experience ponded water for an extended period of time following significant rainfall events. The ponded water is stagnant with no outlet and can produce odour issues in the summer. This issue was experienced following the February 2018 and May 2021 events (refer Attachment i), however has not been as problematic following the more recent December 2021 and February 2022 events. The current condition of the area is shown in Figure 7 below.

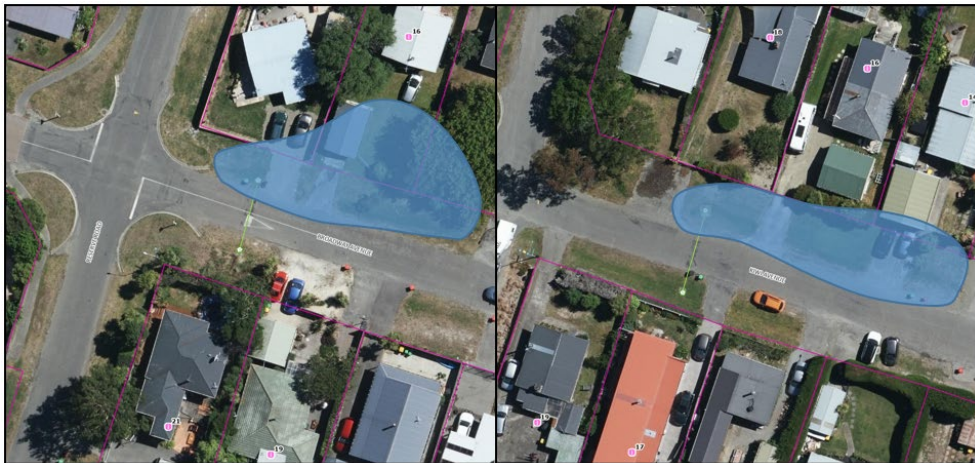
Figure 8 – Location of flooding at the low points in Reserve Road/Broadway Avenue and Kiwi Avenue

4.26. Flooding of two low lying garages, one in Broadway Avenue (just off Reserve Road) and one in Kiwi Avenue (refer Figure 8 below), have occurred in December 2021 and February 2022 events. Both these areas are serviced by two soak pits and there is no piped drainage system in this area (apart from the pipe under the road linking the two soakpits). The ground east of Reserve Road is lower than surrounding area so there is no defined secondary flow path.

4.27. Jetting and CCTV inspection of the pipes has been undertaken and a topographical survey has been completed. The soakpits need to be fully remediated to ensure they are functioning as intended. This work has been issued to the Roading maintenance contractor and is programmed to be undertaken in the next month.

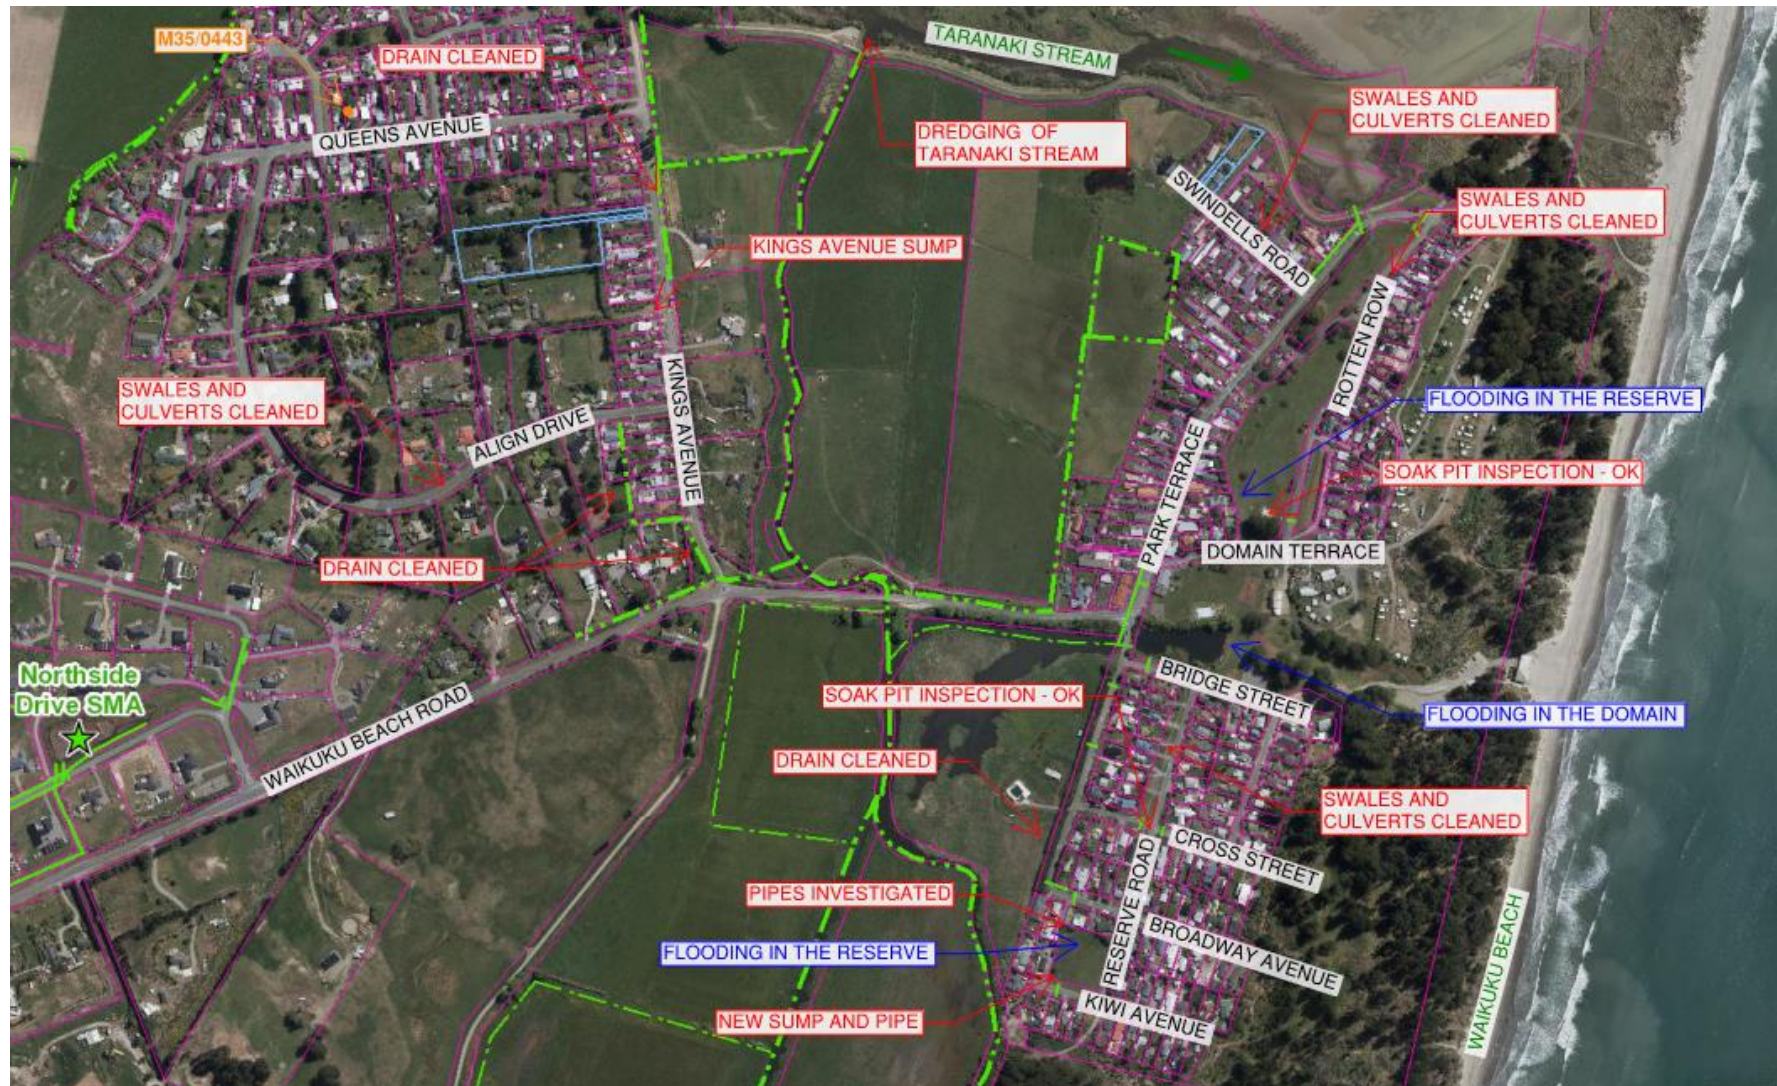
Figure 1. Waikuku Beach maintenance and investigations undertaken since July 2018. Red items are completed works / investigations and blue items are ongoing issues.

Figure 1 summarises the works undertaken and the drainage issues still to address.

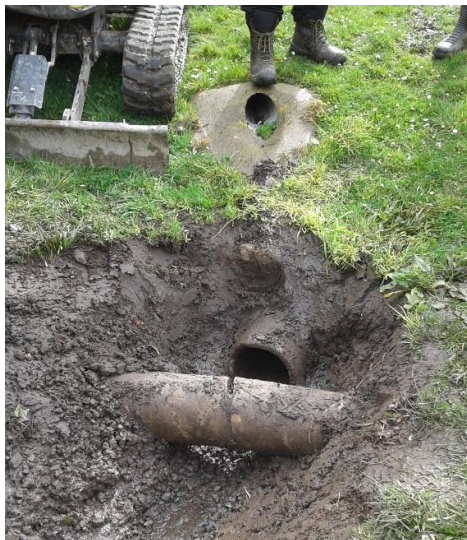
Figure 2. Reserve Road water main and drainage outlet to lagoon.

At the northern end of Reserve Road in the western berm a water main was exposed (Figure 2). The WDC Water Unit lowered the water main, but in the process disrupted the drainage from Reserve Road to the lagoon by removing a section of the outlet pipe and burying the pipe inlet. The WDC Roding team are currently in the process of locating the outlet of the pipe and will reinstate as required.

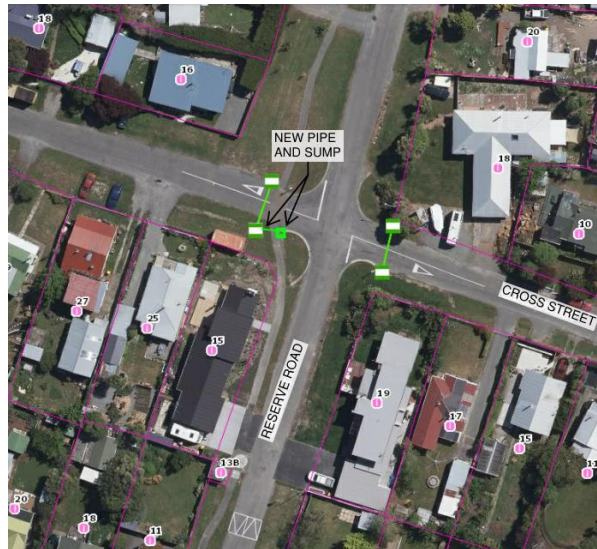
Figure 3. New sump and pipe recently installed by Roding at the intersection of Cross Street and Reserve Road.

The Roding team are also currently working on an issue at 15 Reserve Road. The level of the property is low. Consequently, stormwater from the road flows into the property. Roding have recently installed a new sump on the Reserve Road footpath with a pipe connection discharging to an existing sump (which then discharges to a soak pit), refer to Figure 3. The impact of this work should be monitored.

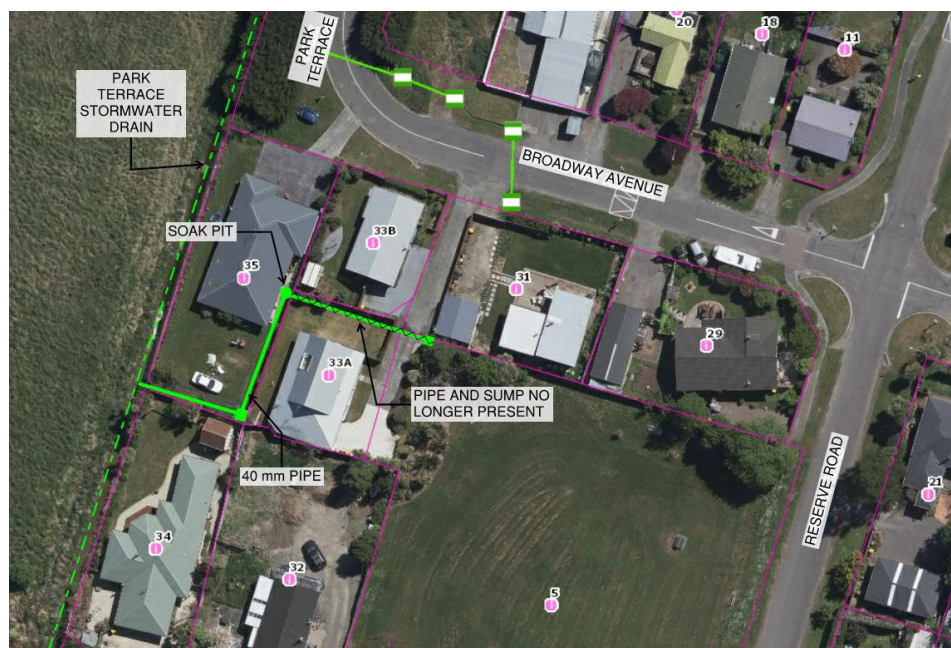
Figure 4. 35 Broadway Avenue stormwater pipes.

CCTV was attempted (October 2018) to confirm the location and condition of the pipes and sumps. It was found there is a soak pit at the end of the pipe in 35 Broadway Avenue and it does not extend to the reserve (Figure 4). These pipes are not shown in WaiMaps.

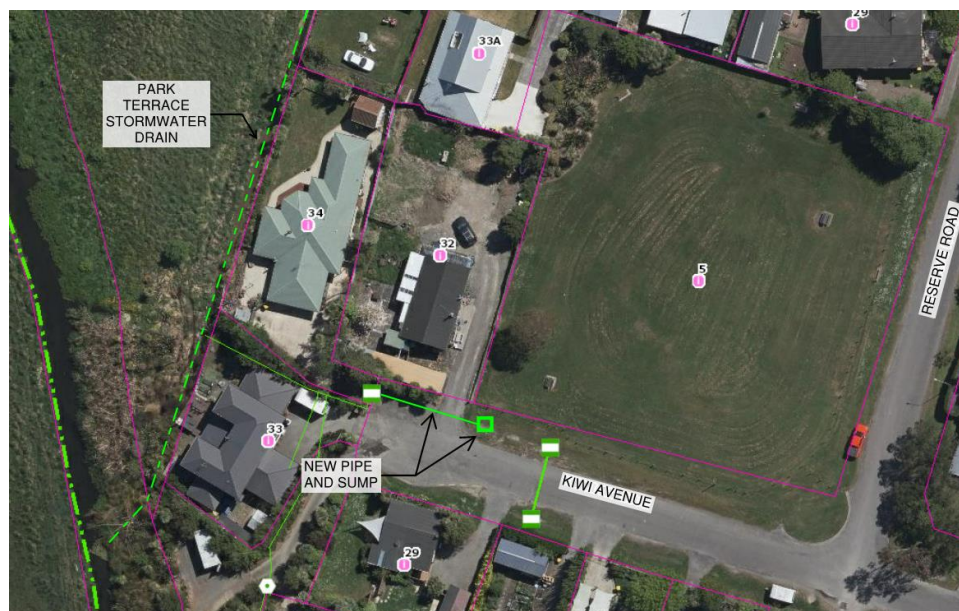
Figure 5. Kiwi Avenue drainage works.

At the southwest corner of the reserve, on Kiwi Avenue, the Roding team have recently installed a new sump and pipe connection to an existing sump, which discharges west into the Park Terrace drain (Figure 5). This is to address the issue of ponding water along the southern end of the reserve. The impact of this work should be monitored, and further work investigated. In particular the northeast of the reserve should be monitored, and options investigated if drainage issues persist.

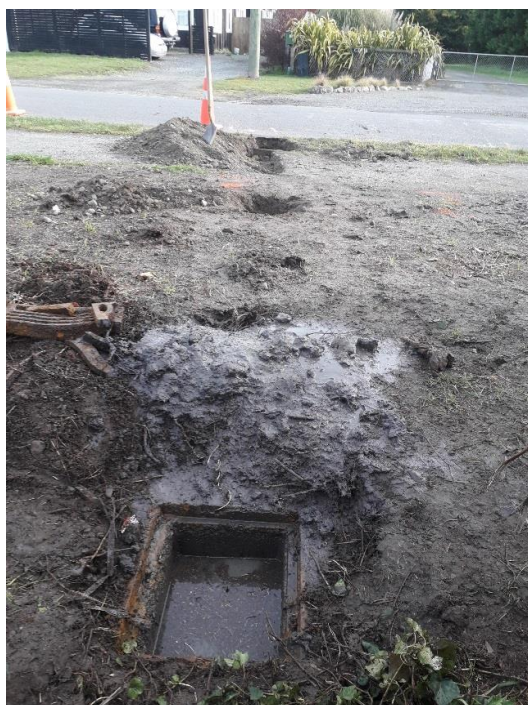
Figure 6. Kings Avenue downstream bubble-up sump opposite 37 / 39 Kings Avenue.

Investigations identified this sump is the upstream sump of a bubble-up system across Kings Avenue. The downstream sump was located and exposed (Figure 6). The sumps and pipe were cleaned out (August 2019) and are now functioning.

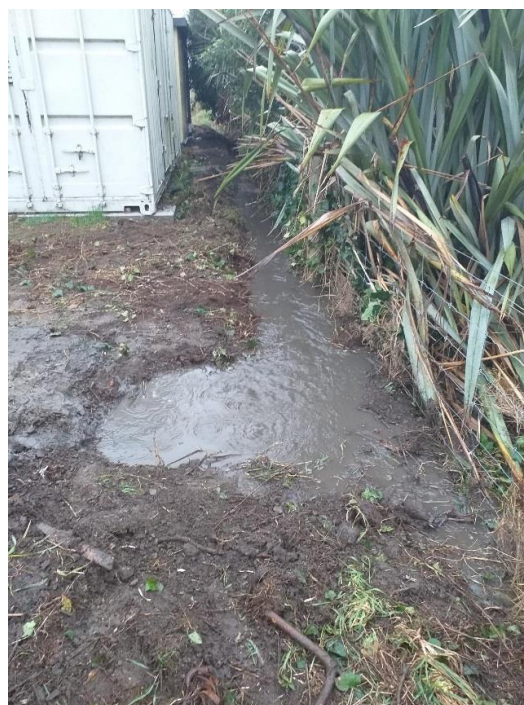
Figure 7. Kings Avenue downstream bubble-up sump opposite 37 / 39 Kings Avenue, and drainage path to the north behind the water pump station.

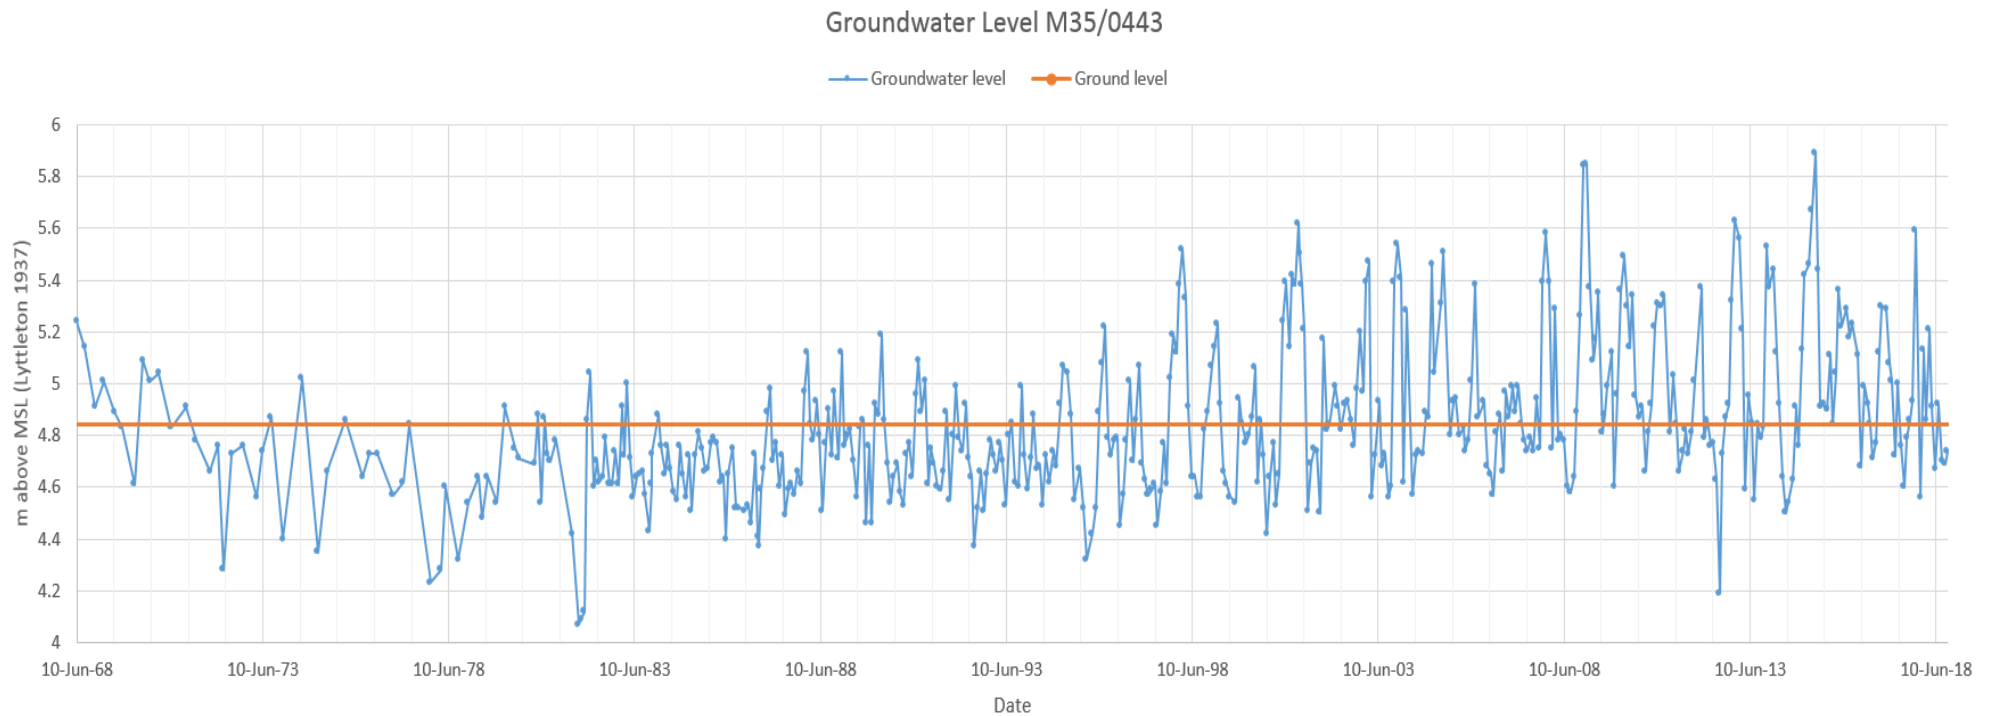
Figure 8. Groundwater data from M35/0443. The ground level measured at the location of the well (4.84 MSL) is shown by the orange line.

The consequence of the high groundwater levels is that the period of time in which water is able to effectively drain from the area is reduced. This leads to water ponding on the surface for longer periods of time.

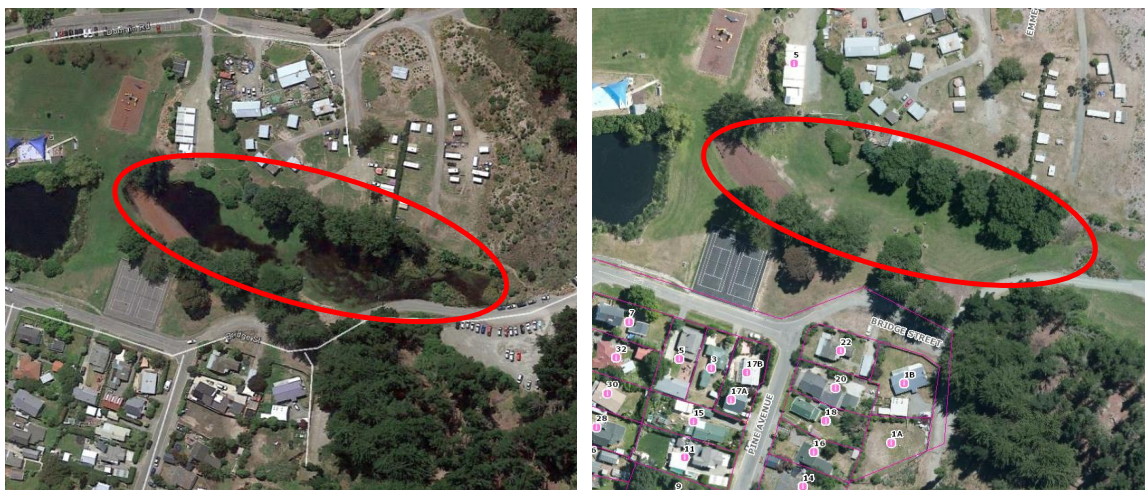
Figure 9. Waikuku Beach domain. The left image is from 2018 and shows the area of the domain (circled in red) which experiences regular flooding. The right image from 2014 shows the area without flooding.

- High groundwater
- Old land fill site – it is possible ground settlement has occurred
- Ground movement following the Kaikoura earthquake.

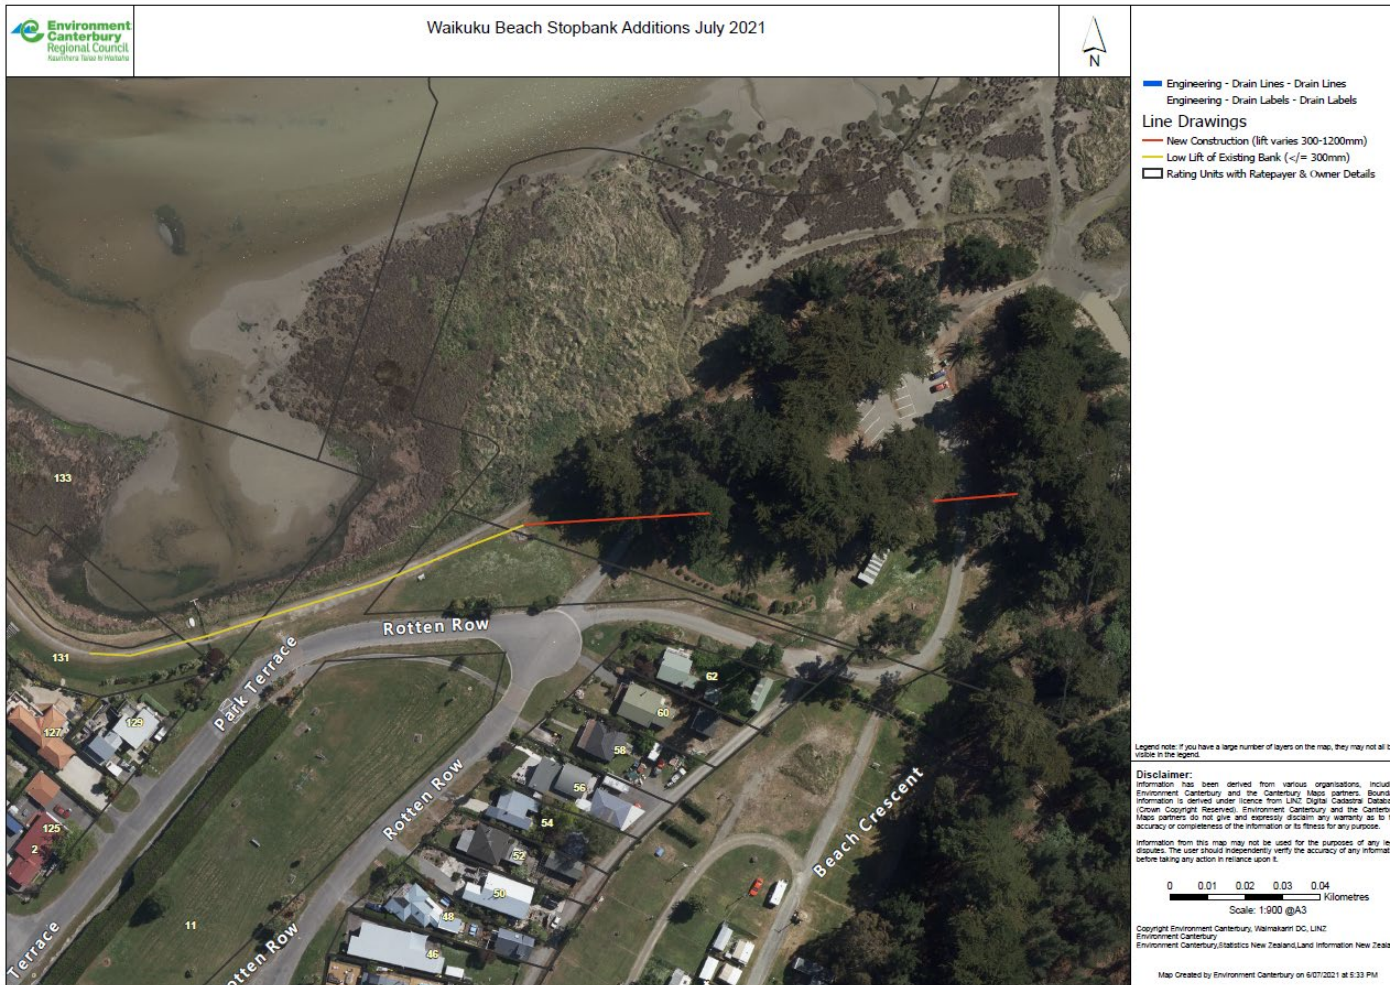
Line Drawings

- New Construction (lift varies 300-1200mm)
- Low Lift of Existing Bank ($\leq 300\text{mm}$)
- Rating Units with Ratepayer & Owner Details

- 500-600mm high carpark accessway ramps up over the extended stopbank
- Commence this month and take approximately 3 weeks to complete

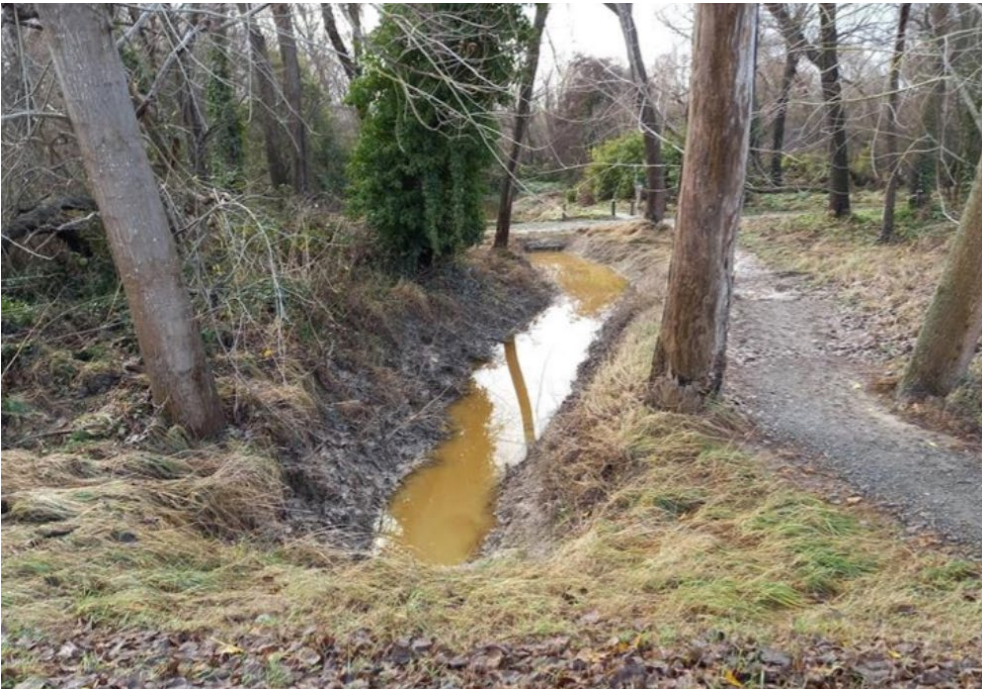
Collins Drive

- Backflow occurred through the stormwater system

- Proposed Works
 - Improve the operation of the existing flapgate - access for maintenance, protection from debris blockage during events
 - Install a secondary flapgate – potentially a Wastop valve

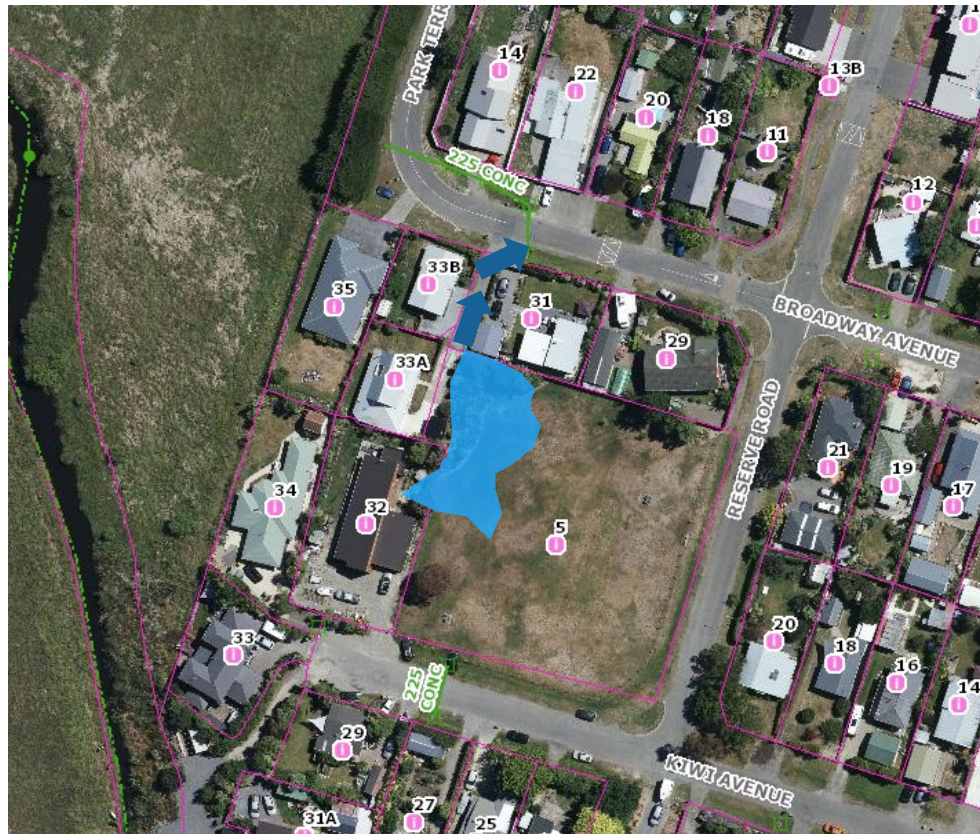
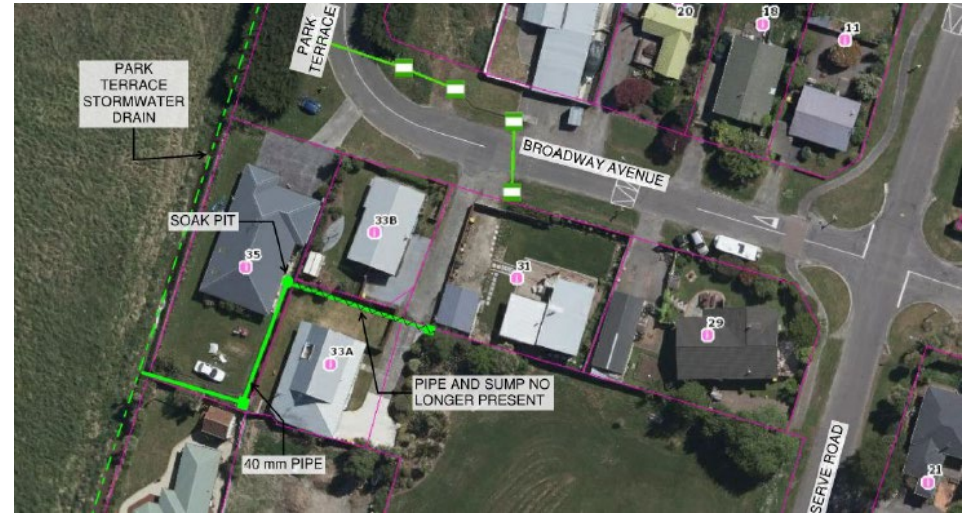
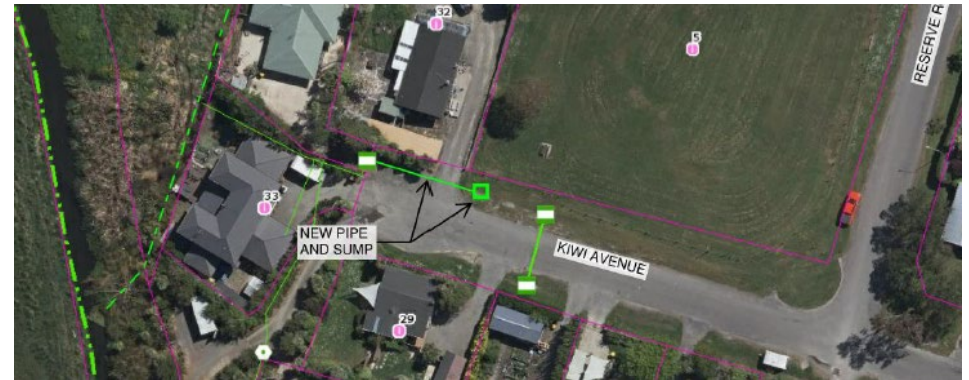
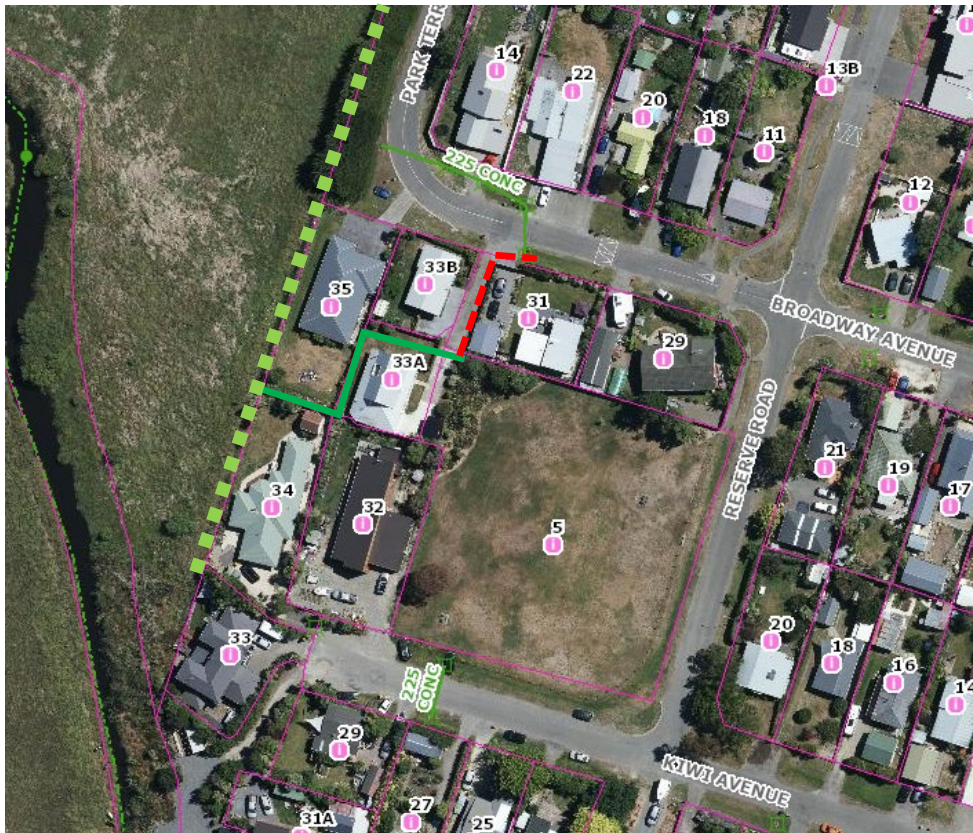
- Drainage assessment
 - Level survey of park
 - Investigate options:
 - Upgrade existing system through 33A / 35 Broadway to Park Terrace Drain
 - New system through driveway of 33A Broadway to stormwater system in Broadway Ave
 - Raise land in reserve?

| LOCATION | ASSESSMENT |
|---|---|
| Kiwi Avenue Reserve | Flooding occurred in the north west part of the reserve. While upgrades had previously been completed in Kiwi Avenue the stormwater system from this part of the park is inadequate. The options to be considered are upgrading the pipe out to the Park Terrace Drain or installing a new pipe out to Broadway Avenue. |
