WAIMAKARIRI
DISTRICT COUNCIL

Utilities and Roading Committee

Agenda

Tuesday 21 June 2022

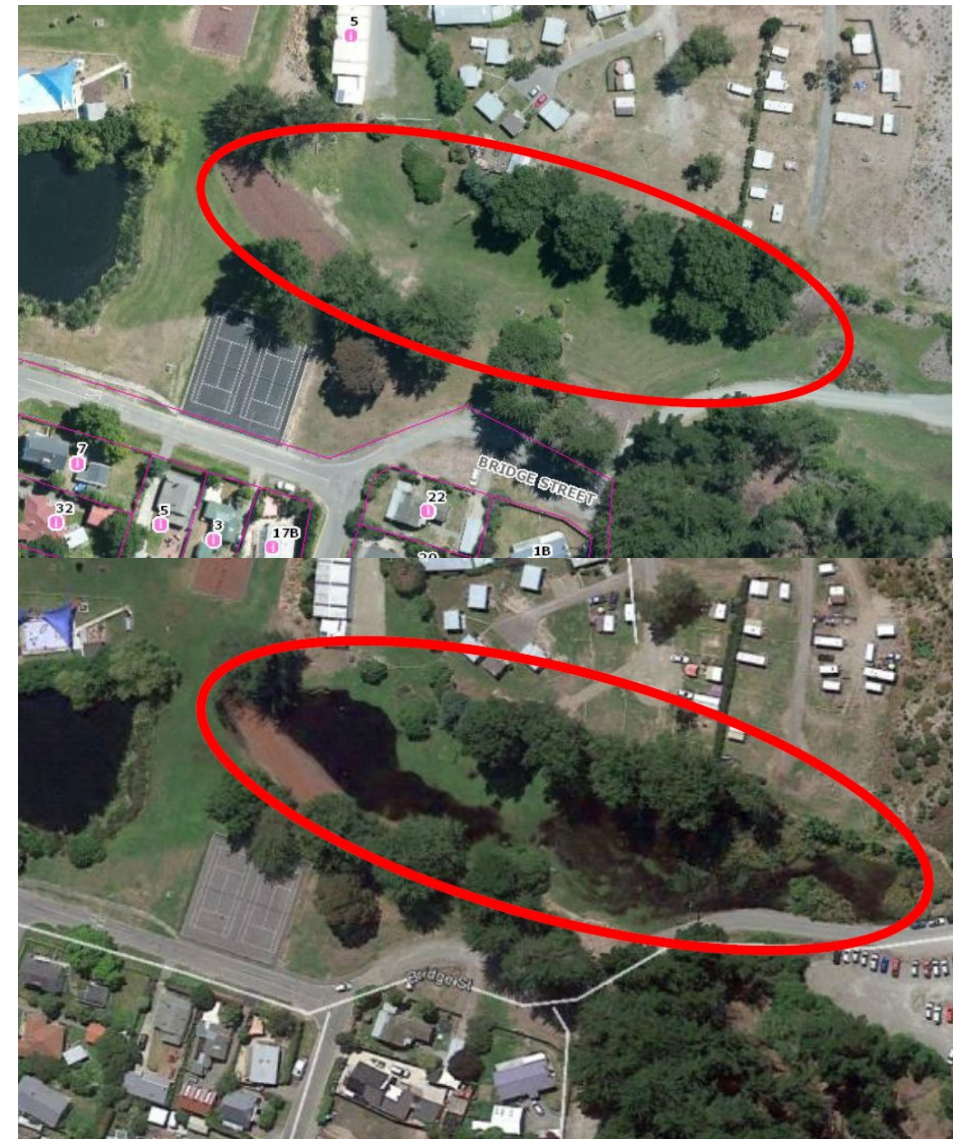
Waikuku Beach Reserve

- Ponded water for extended durations
 - Stagnant – smell issues in summer
 - Temporary pumping not feasible?
- Drainage assessment (Greenspace)
 - Groundwater and geotechnical assessment (old landfill)
 - Level survey of park
 - Investigate options:
 - Filling of the low areas
 - Installing subsoil drainage
 - Converting area to a permanent wetland
 - Creating a bund around the western side
 - Installing a pipe to drain the low area
