# Waimakariri District Council

## Utilities and Roading Committee

# Agenda

Tuesday 10 December 2024

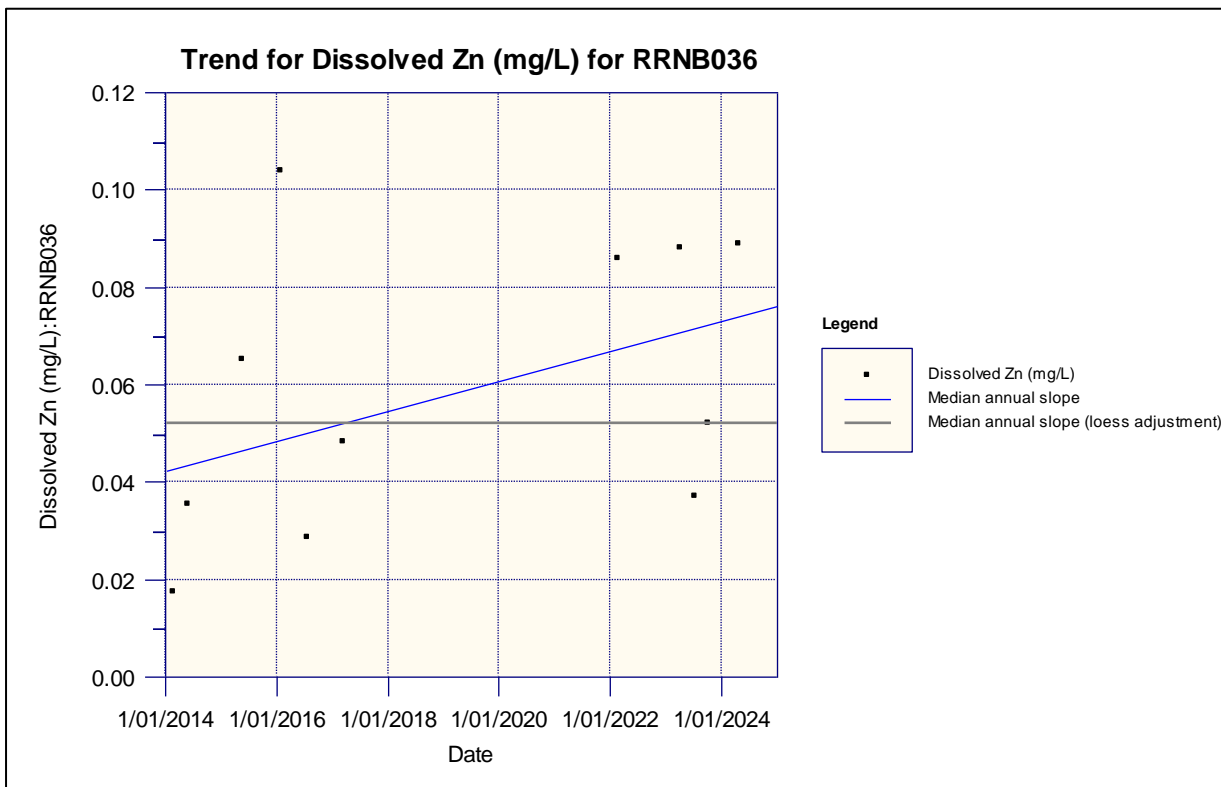
**Figure 7. Dissolved zinc trend in the North Brook, Lilybrook Park RRNB036: Increase trend possible (from stats, see Appendix 2-G)**

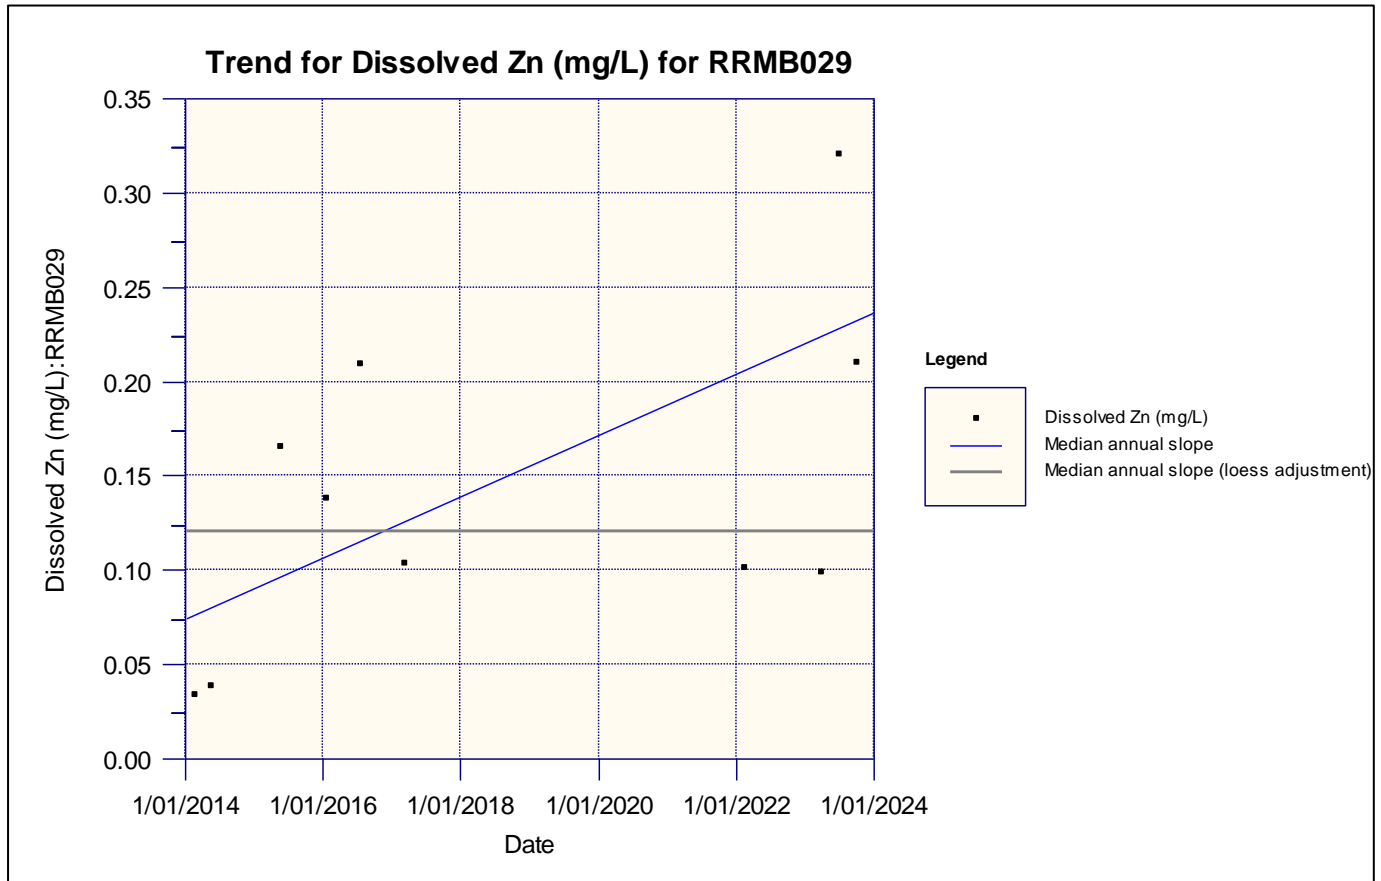
Figure 8. Dissolved Zinc trend in the Middle Brook, Bush Street RRMB019: Increase trend possible (from stats, see Appendix 2-G)

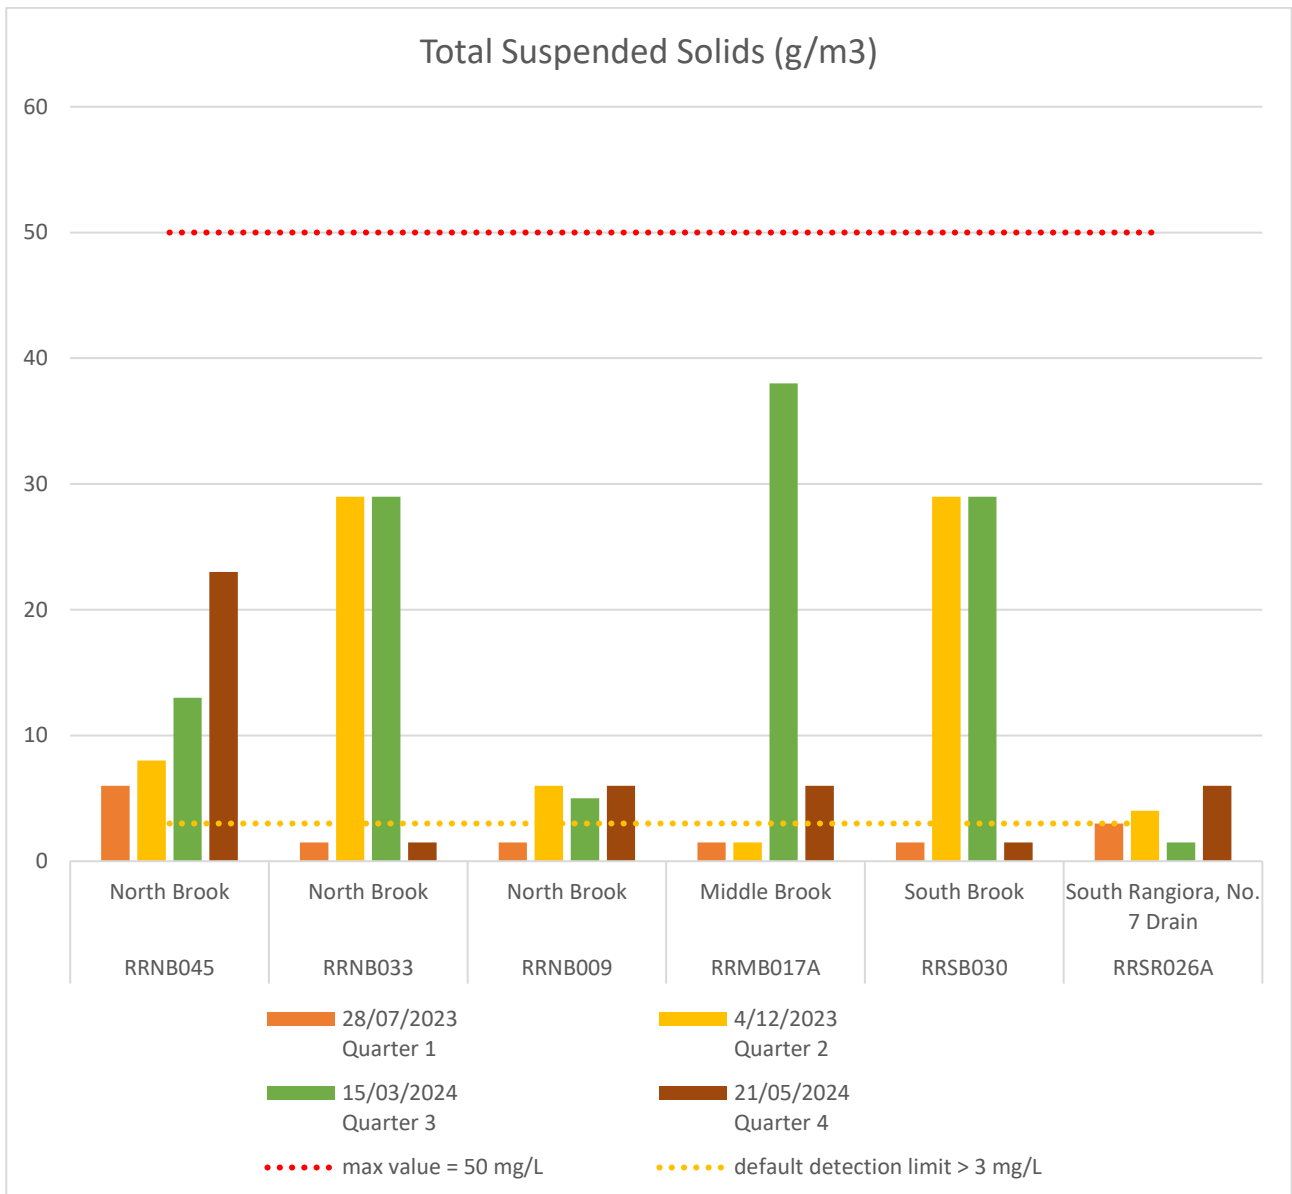
Figure 12. Total suspended solids for Major Network Outlets sampling FY 23/24. Values below the default detection limit, are represented as half the detection limit (1.5 mg/L).

Figure 12 shows the TSS results for FY 23/24.

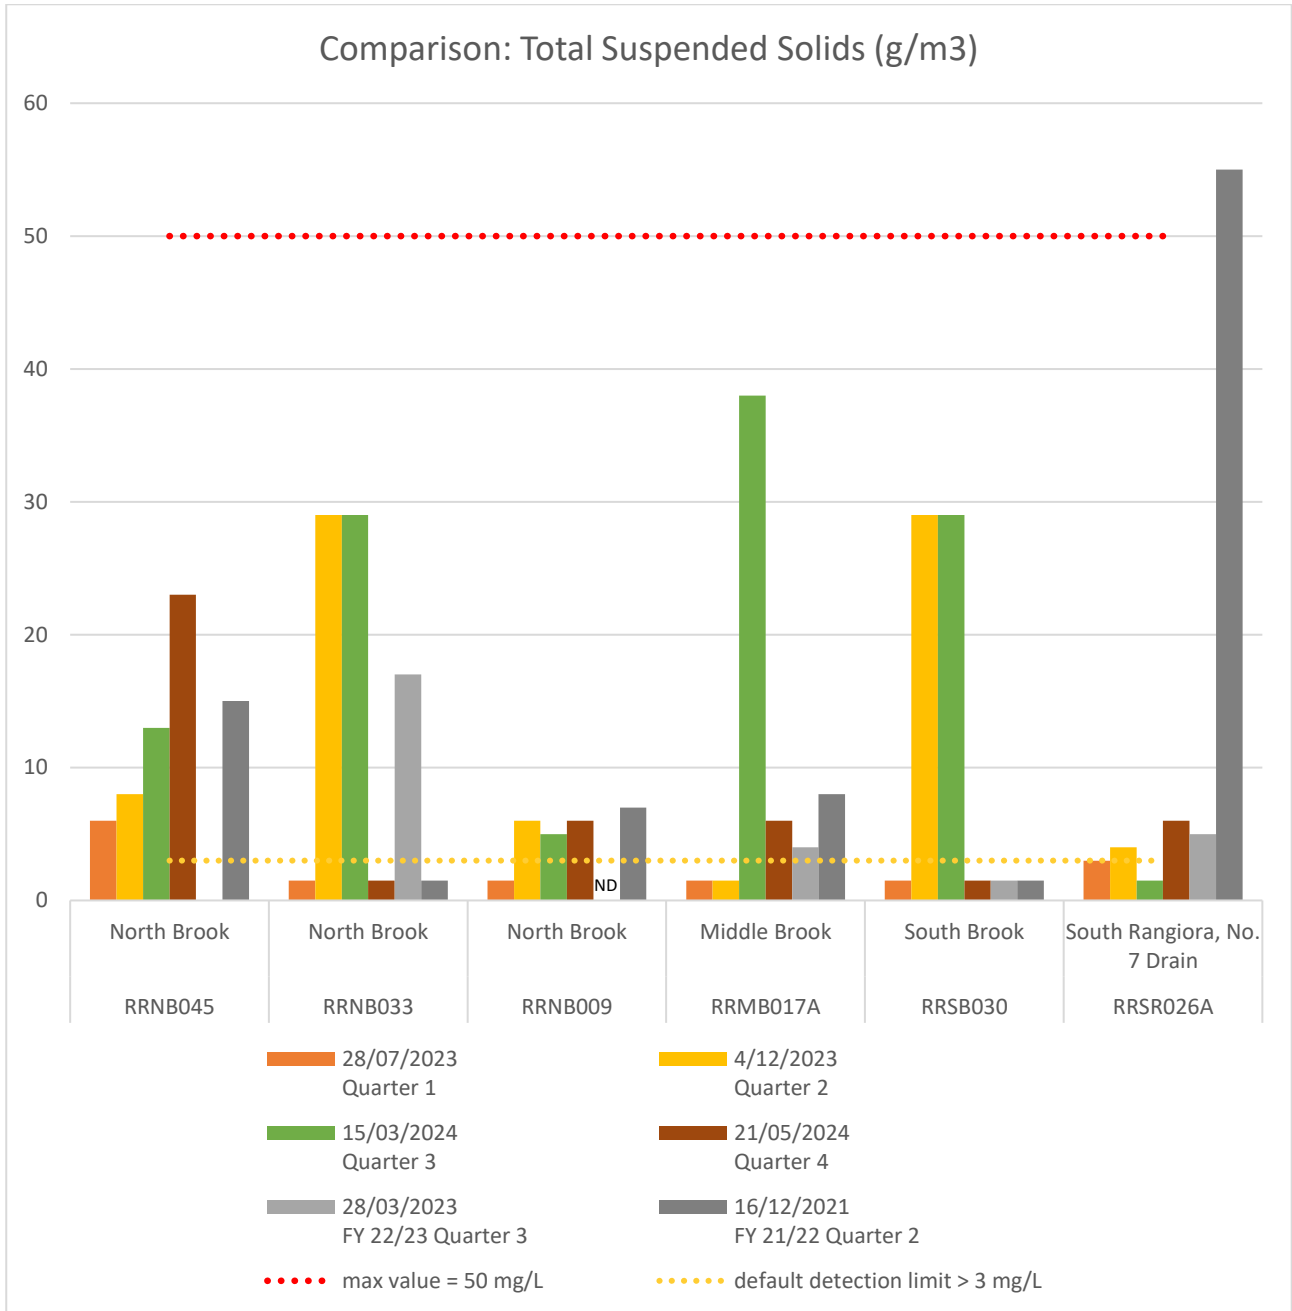
Figure 13. Comparison of total suspended solids results for Major Network Outlets, of sampling from FY 23/24 (in colour) and previous financial years (in grey). Values below the default detection limit, are represented as half the detection limit (1.5 mg/L). ND = No Data (round missed).

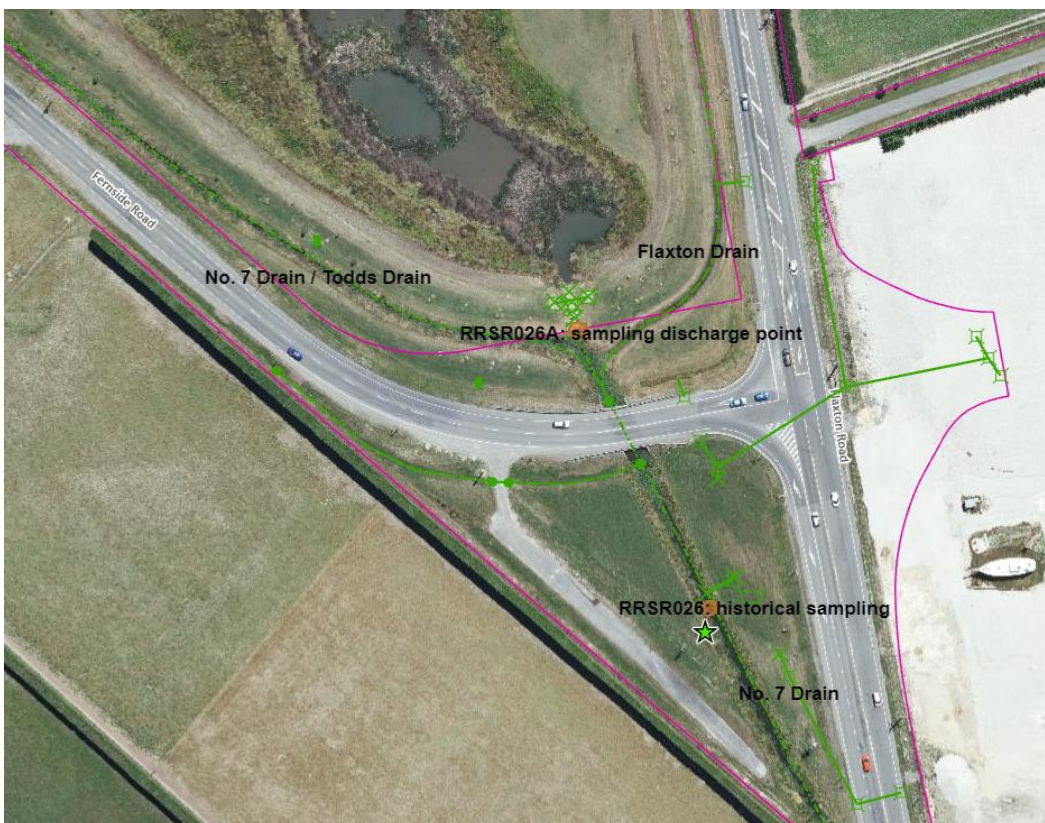
Figure 14. Discharge sampling points and baseline (historical sampling) sites shown in relationship to Pond C and the receiving environment.

Historical sampling for Pond C outlet was undertaken below a mixing zone with the No. 7 Drain (RRSR026). This sampling site can therefore only be used as an indication of historical levels, but it is not a true baseline.

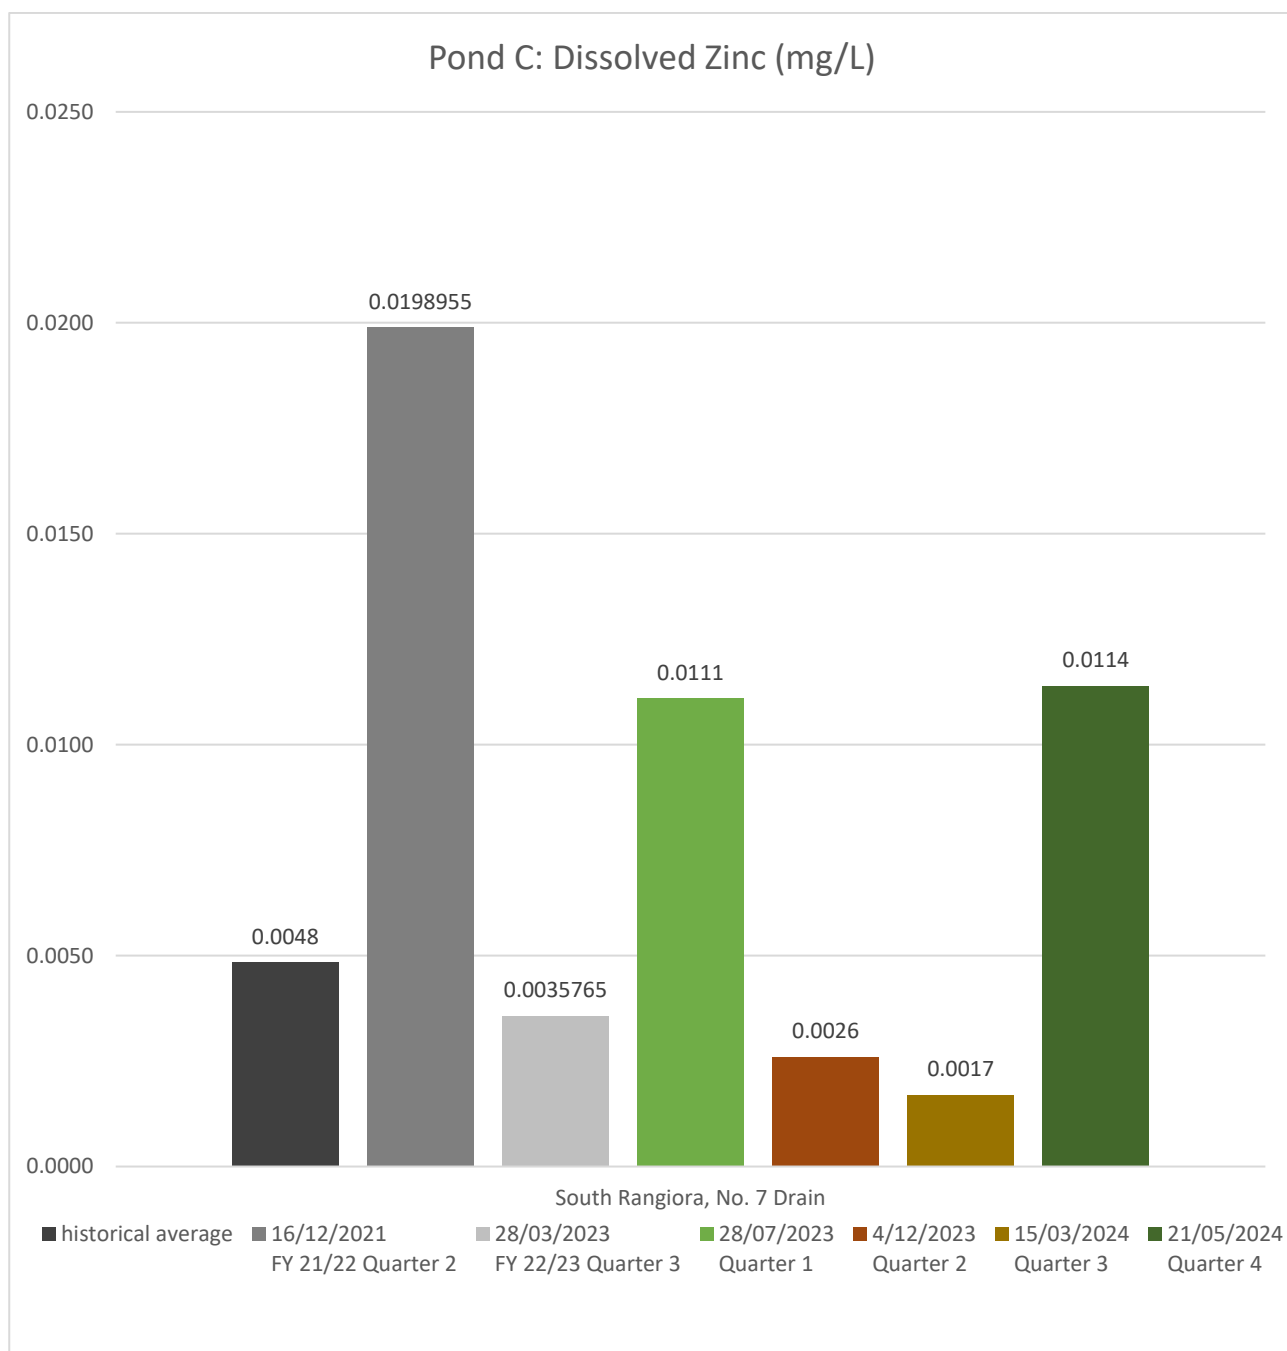
**Figure 16. Dissolved Zinc results from Pond C discharge outlet in FY 23/24 compared to previous financial years and average historical values of dissolved copper (grey).** Note: guideline value added for reference, not for compliance.

Exploratory analyses of all data available provided insight when comparing data from FY 23/24 to previous financial years. A Boxes and Whisker plot showed high variability in the levels of dissolved zinc at Pond C from 2021 to date, with the lowest value being 0.0017 mg/L and the highest being 0.02 mg/L, with most sampling undertaken showing results below the guideline of 0.015 mg/L, between 0.002-0.013 mg/L.

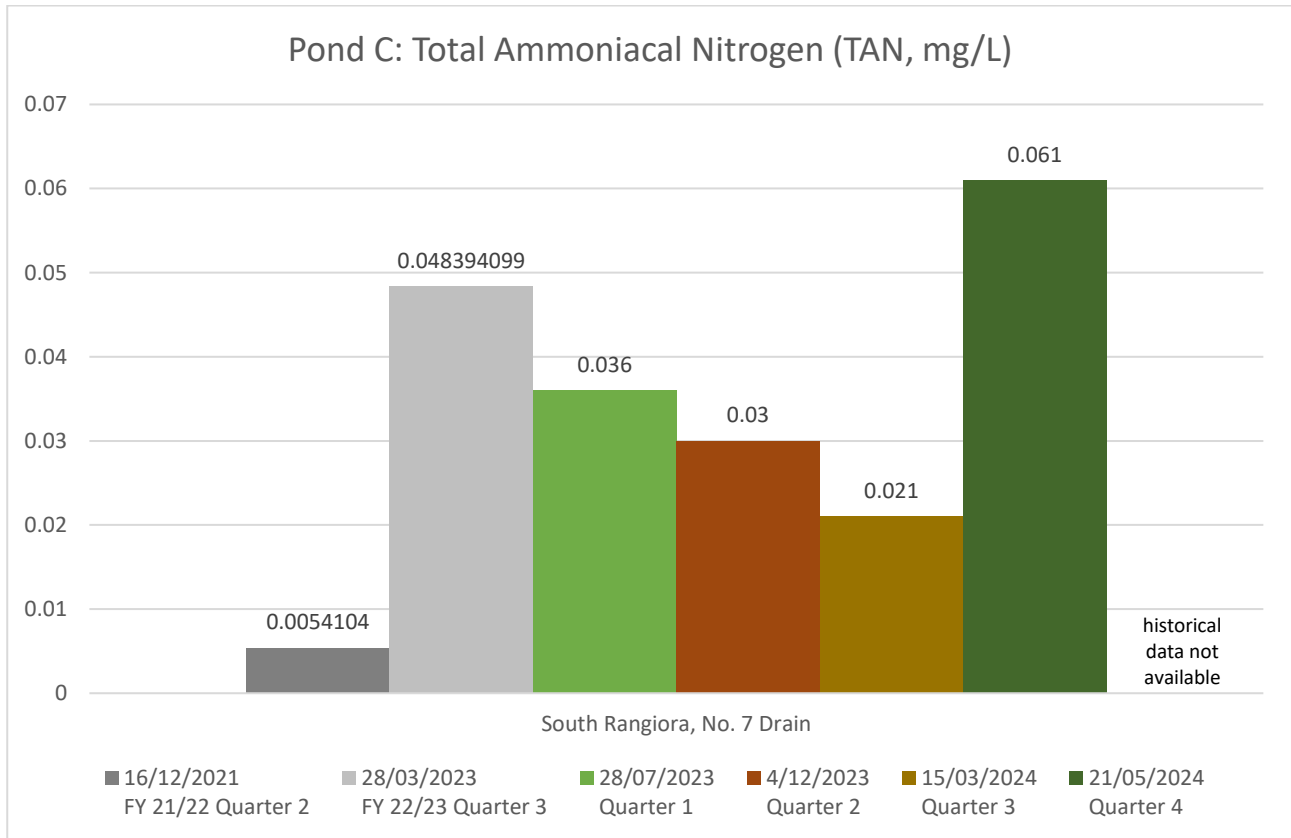
**Figure 17. Total Ammoniacal Nitrogen levels found at Pond C in FY 23/24 (colours), in comparison to previous financial years (grey). There is no historical data associated with this site.**

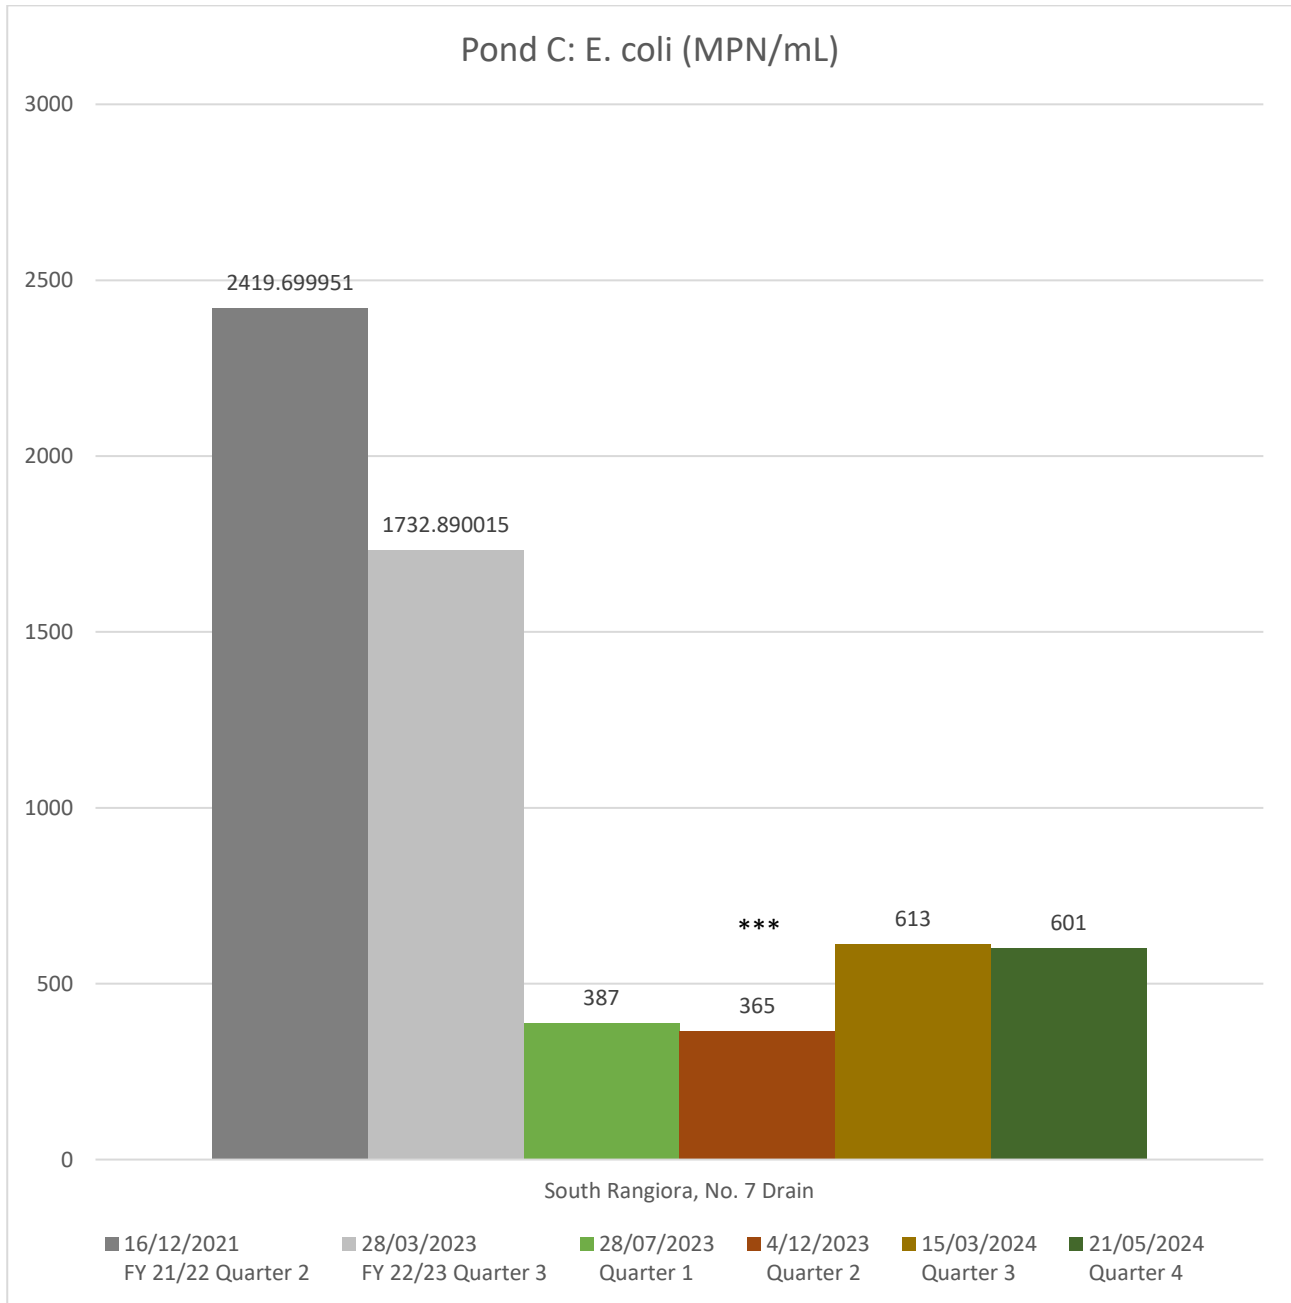
**Figure 19.** *E. coli* levels found at Pond C in FY 23/24 (colours), in comparison to previous financial years (grey). The result marked with (\*\*\*) is advised to be treated with caution by the lab (this sample arrived to the lab above the recommended temperature of 10°)

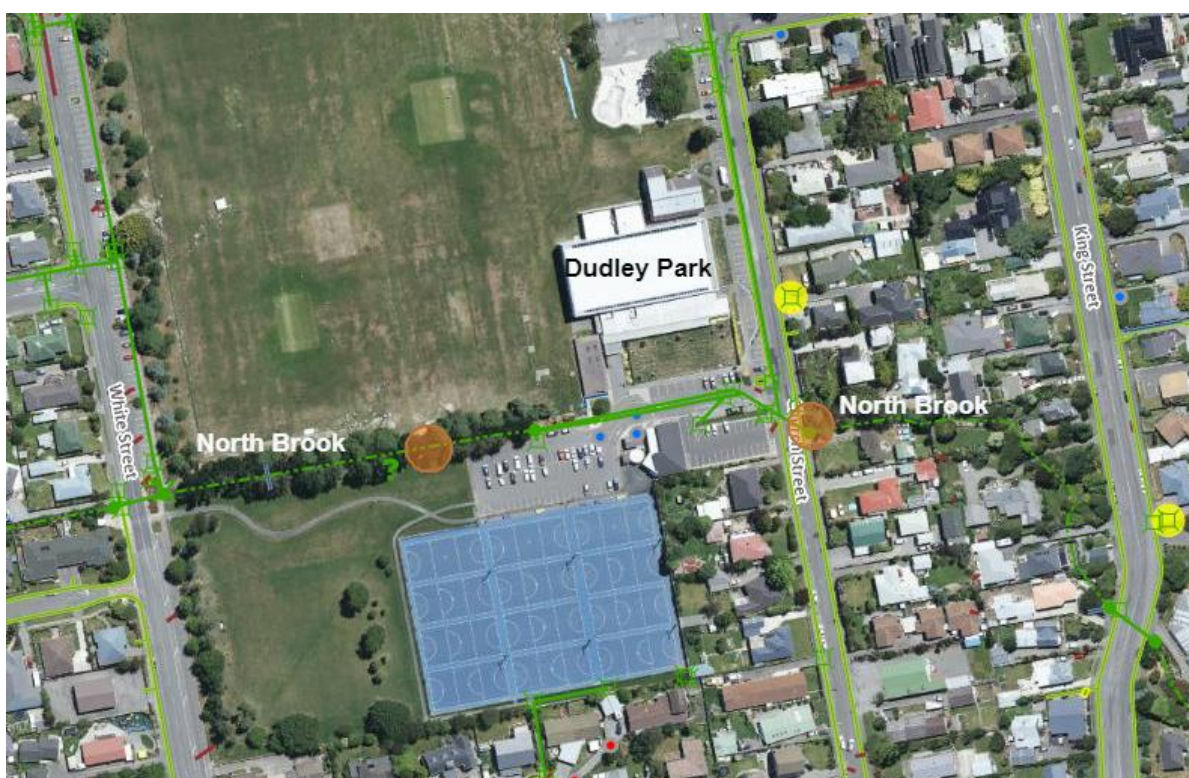
**Figure 21. Dudley Park: Proposed area for stormwater improvements to address dissolved copper exceedances in the North Brook higher up the catchment (RRNB044). Note: these exceedances are currently addressed further down the catchment with North Brook Ponds, with recorded reduced levels of dissolved Copper.**

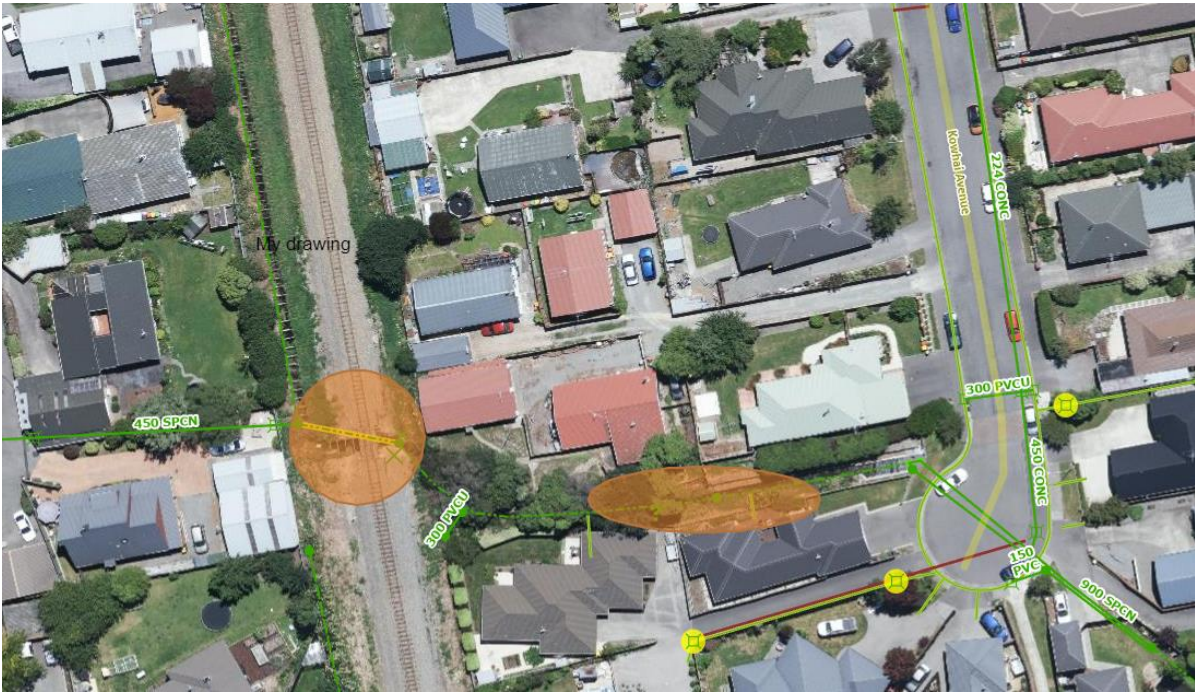
Figure 22. Kowhai Ave: Suggested area for stormwater improvements to address dissolved copper exceedances in the north book higher up the catchment (RRNB033). Note: there is another project underway looking at addressing these exceedances upstream. They are also addressed further down the catchment with North Brook Ponds, with recorded reduced levels of dissolved Copper.

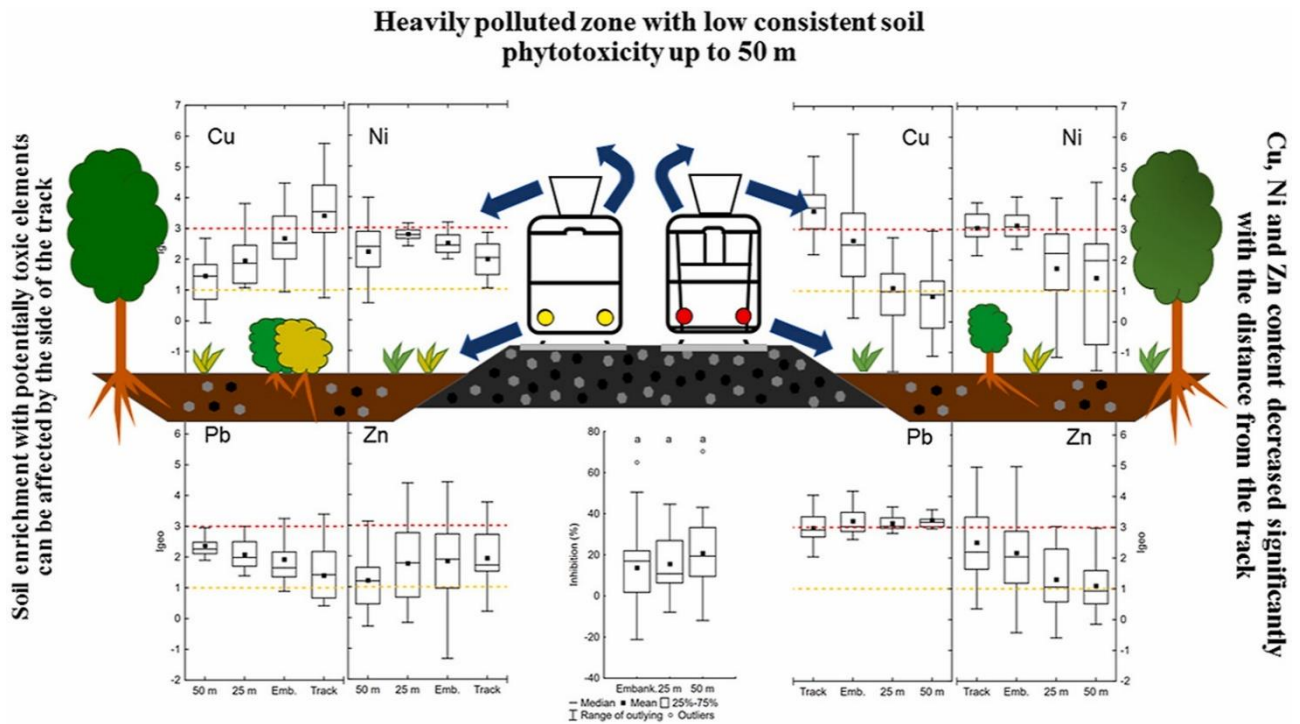
Figure 23. Extract of research results on contaminated land adjacent to a railway. Source: Brtnický et. al 2022.

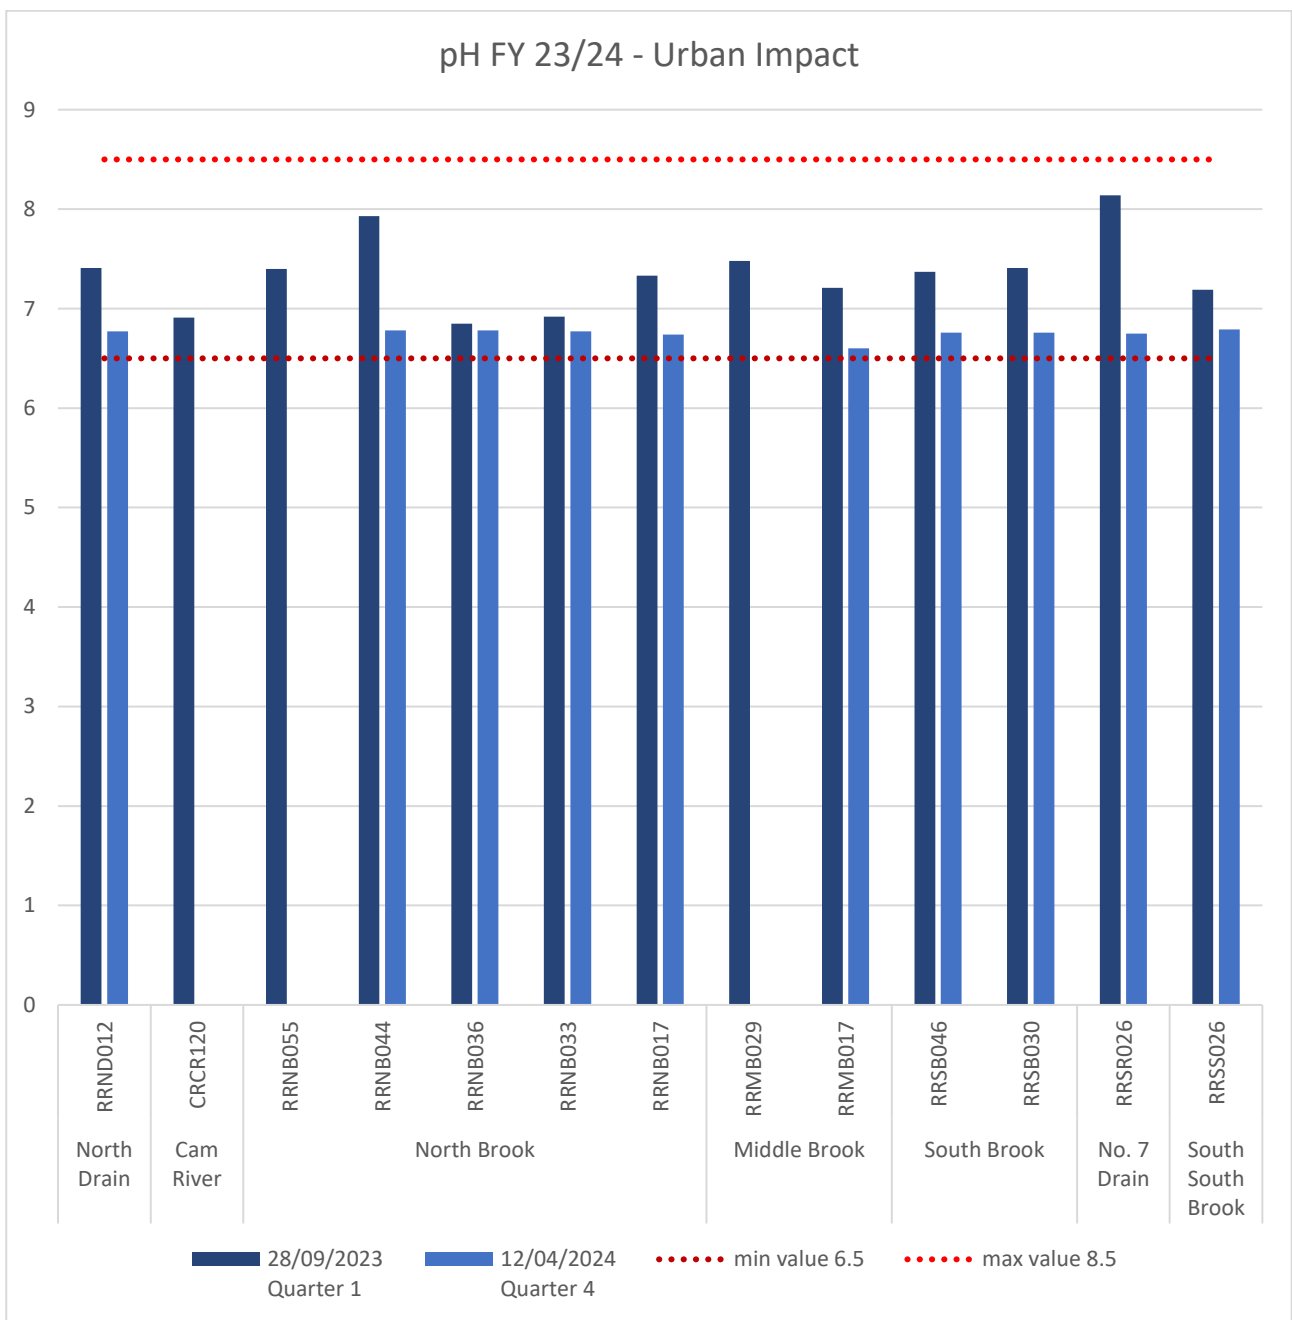
Figure 27. pH values from Urban Impact sampling FY 23/24.

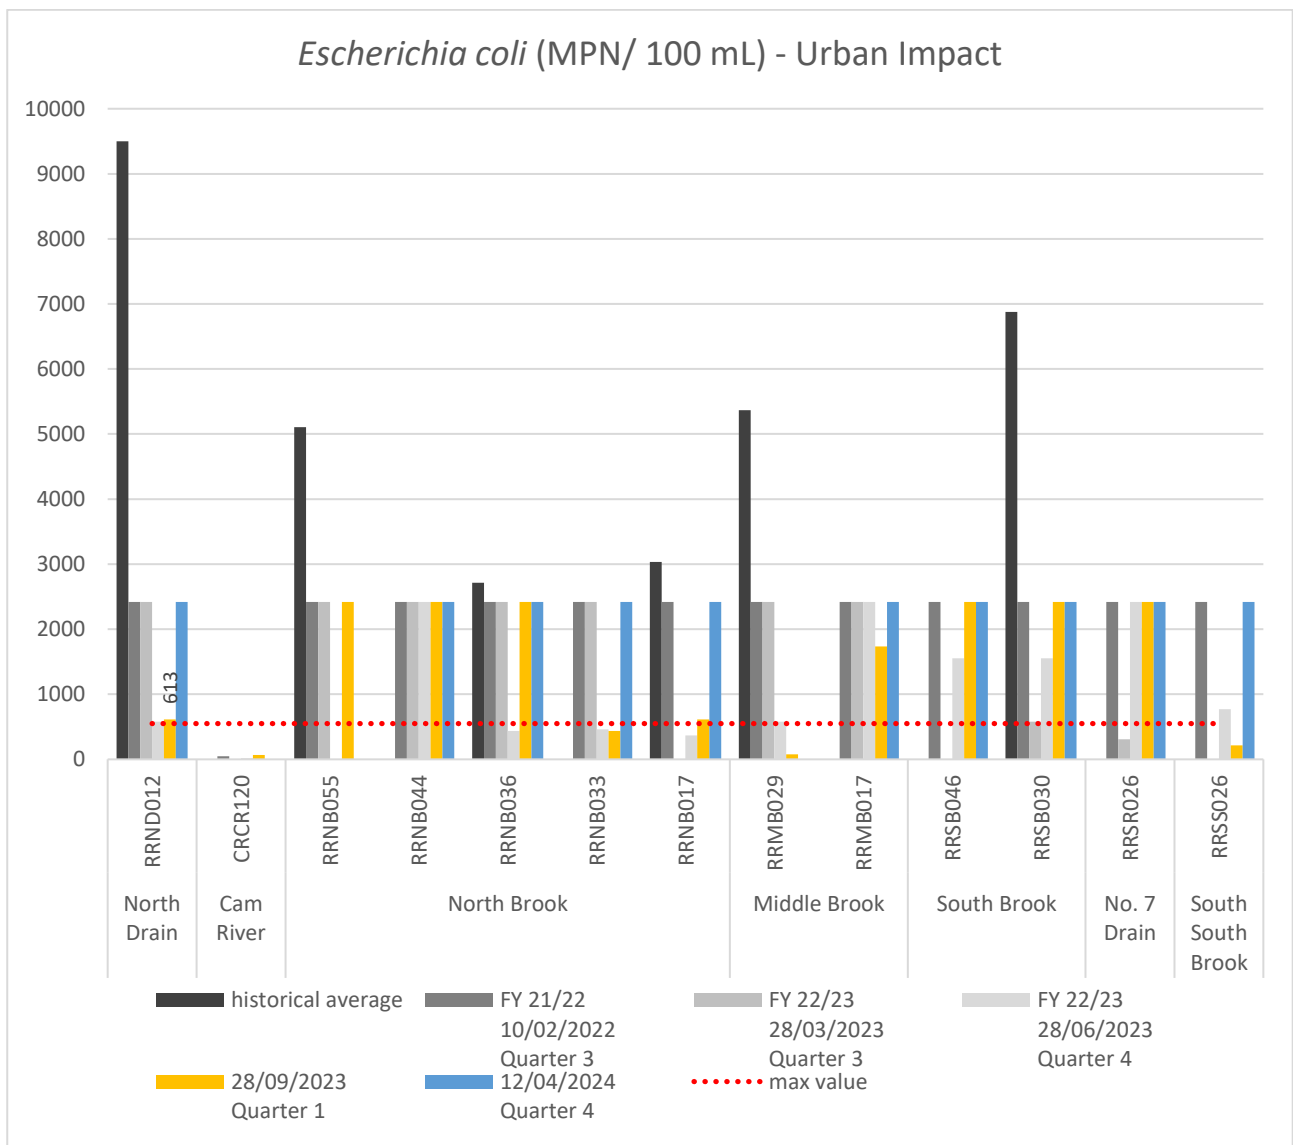
Figure 29. *E. coli* levels found for FY 23/24 (colour) in comparison to previous financial years and historical (grey).

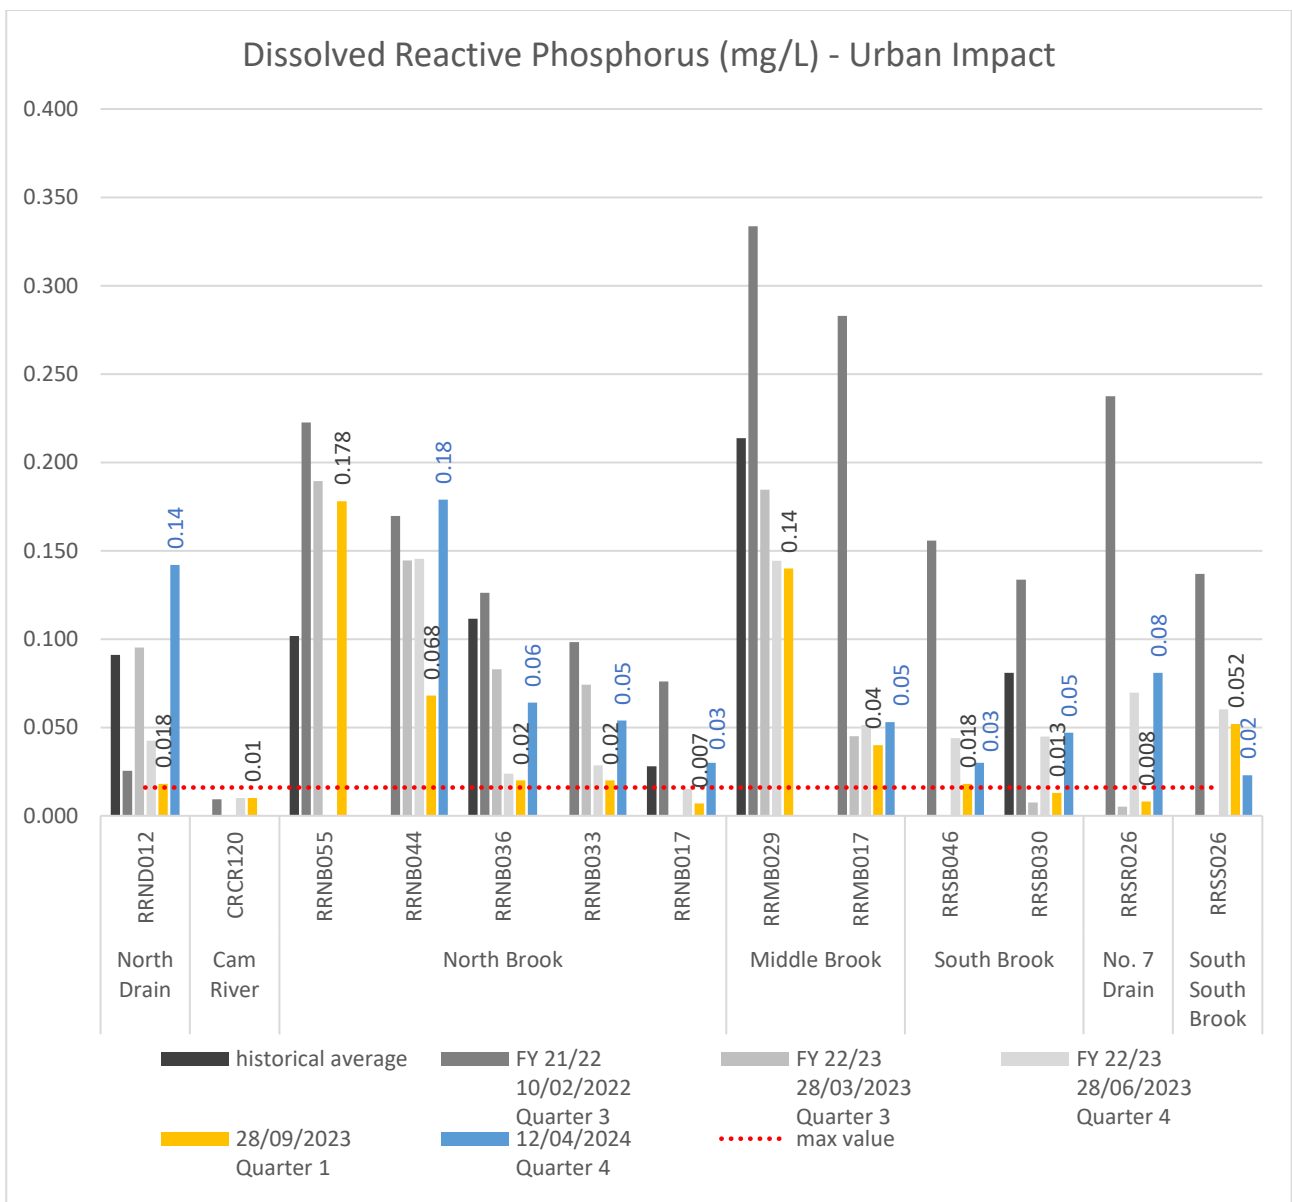
Figure 30. Urban Impact Dissolved Reactive Phosphorus sample results for FY 23/24 (colour) compared to previous financial years and historical results (grey).

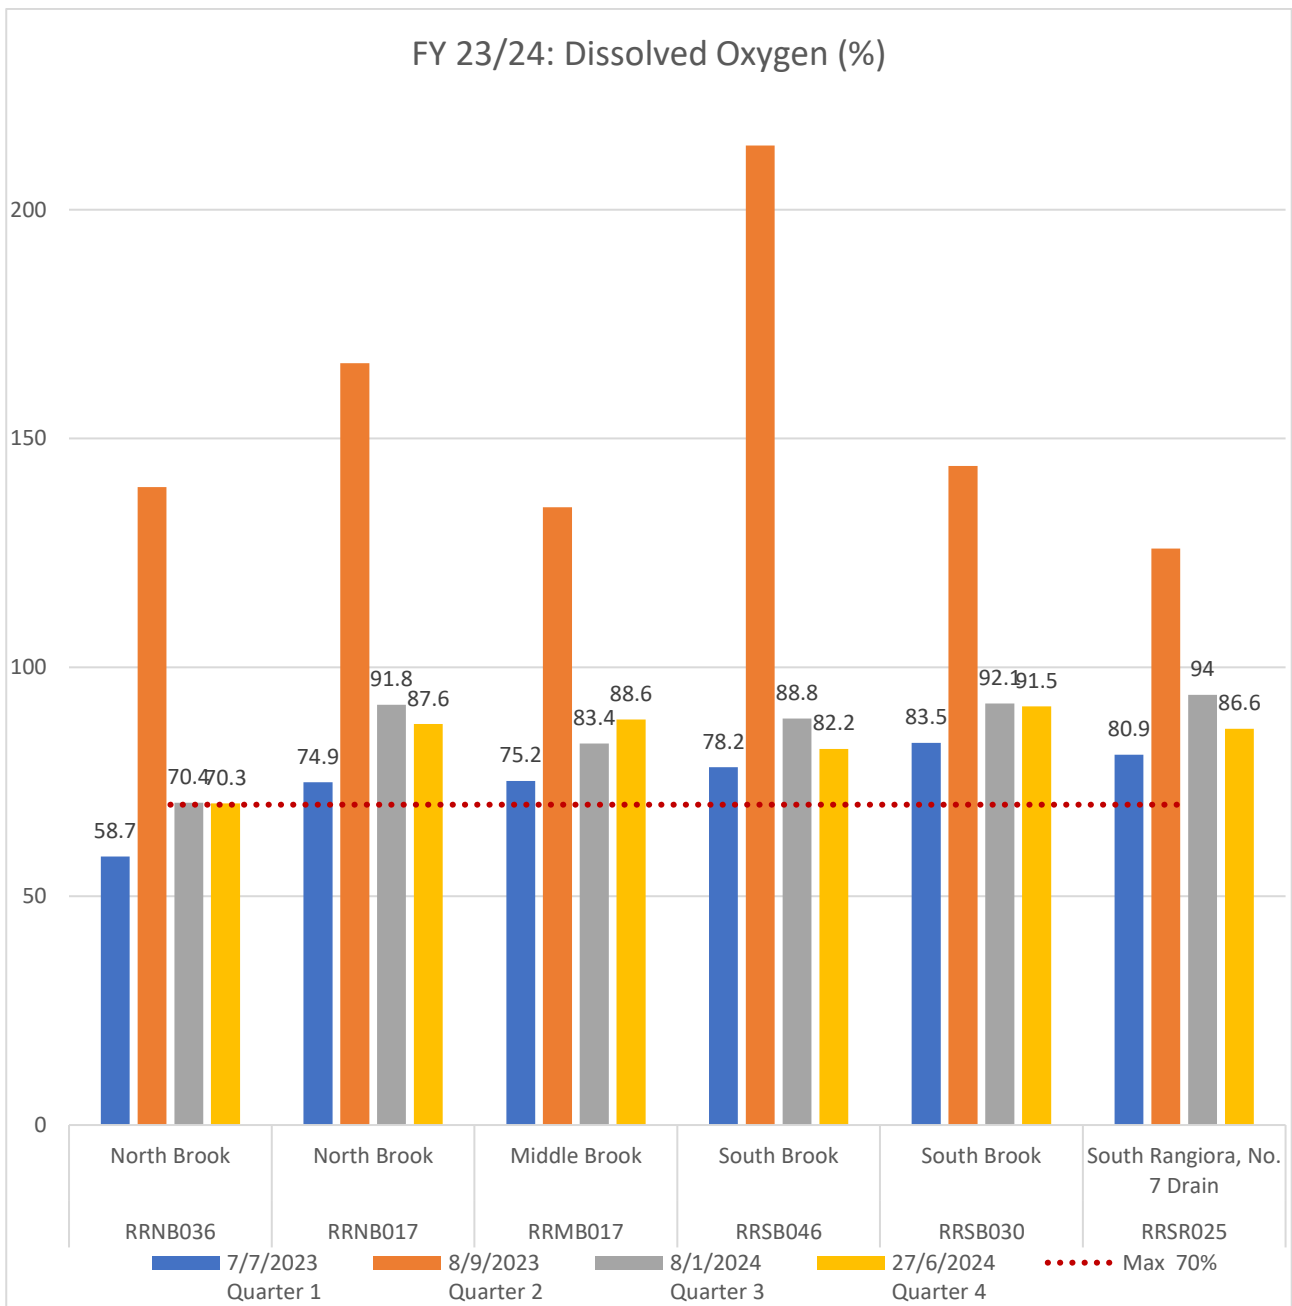
Figure 32. Stream Health - Dissolved Oxygen sample results for FY 23/24

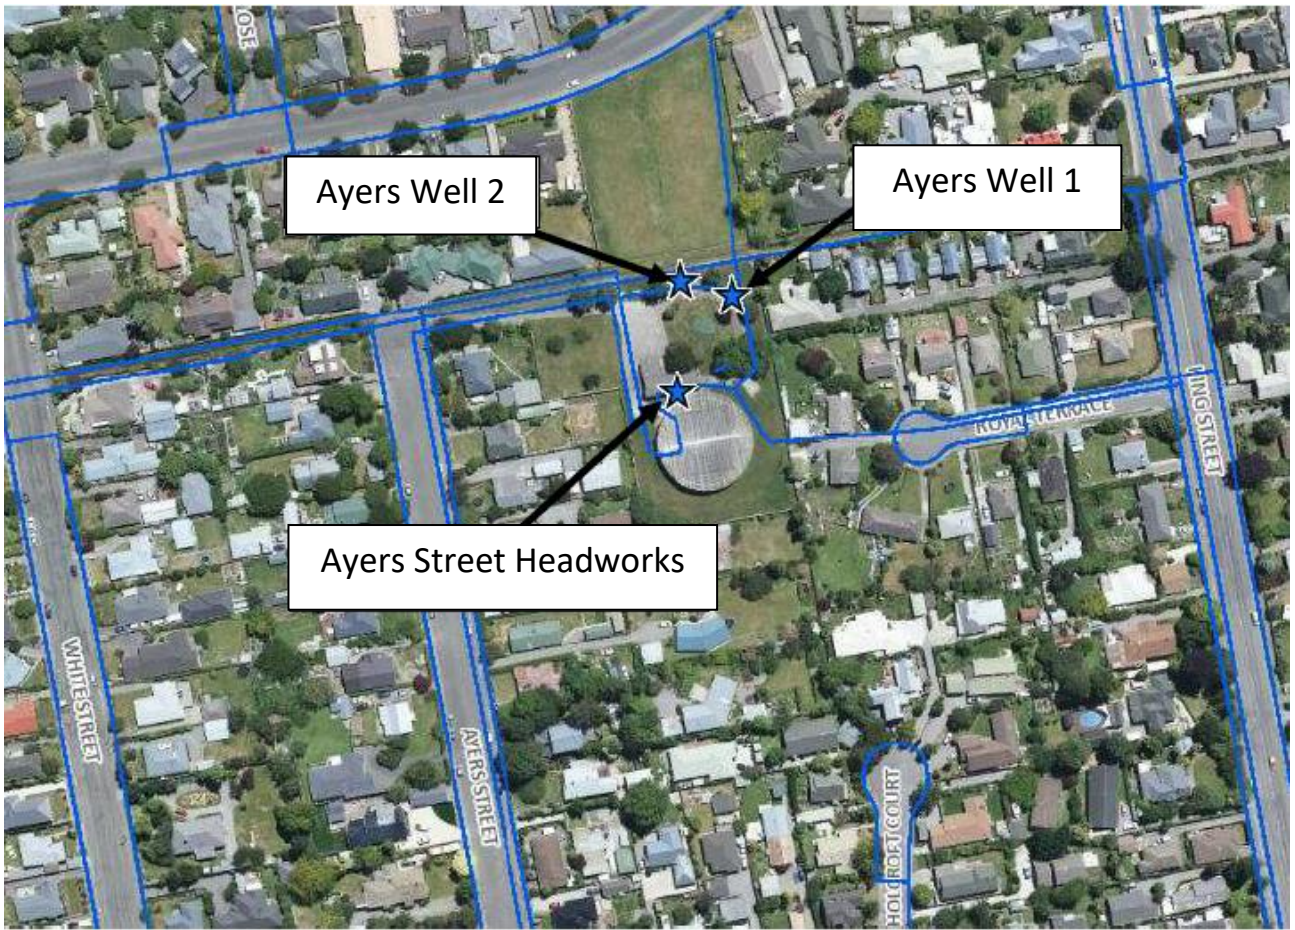
Figure 1. Rangiora Ayers Street Wells and Headworks (Source: Rangiora Drinking Water Safety Plan 2023)

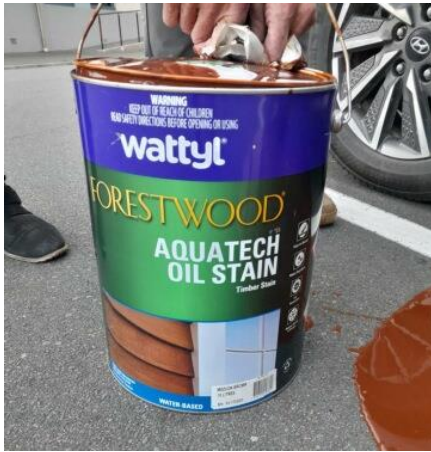
**Figure 1.** Deck primer and associated details identified as the contaminant from a spill.

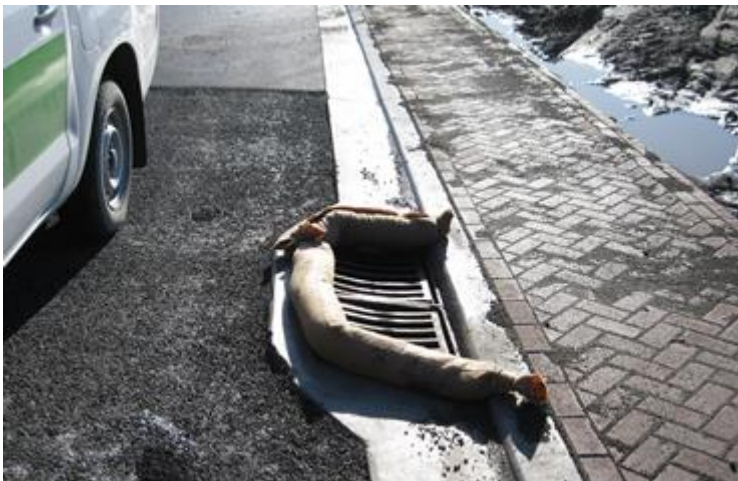
**Figure 2.** Silt socks installed around the sump to protect contaminants from draining inside it.

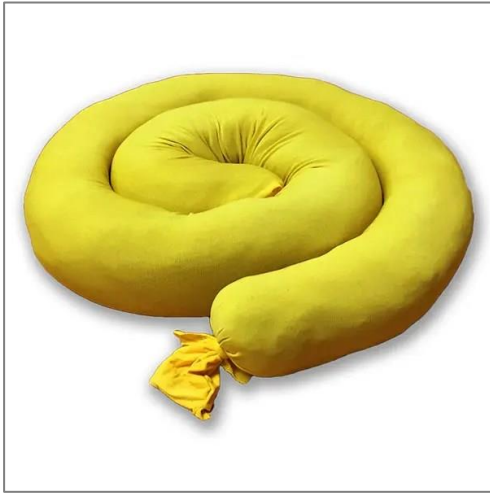
**Figure 3.** Spill fix 1.5m absorbent Boom Sock. An industrial absorbent boom sock made from 100% renewable coir peat, available from a variety of providers (e.g. Riff Safety, NZ Safety Blackwoods)
