**Desktop assessment of Starvation Hill Fault hazard
in relation to a land parcel comprising parts of
Lots 2 and 3, DP 51992, Oxford, North Canterbury**

**GNS Science Consultancy Report 2023/44
March 2024**

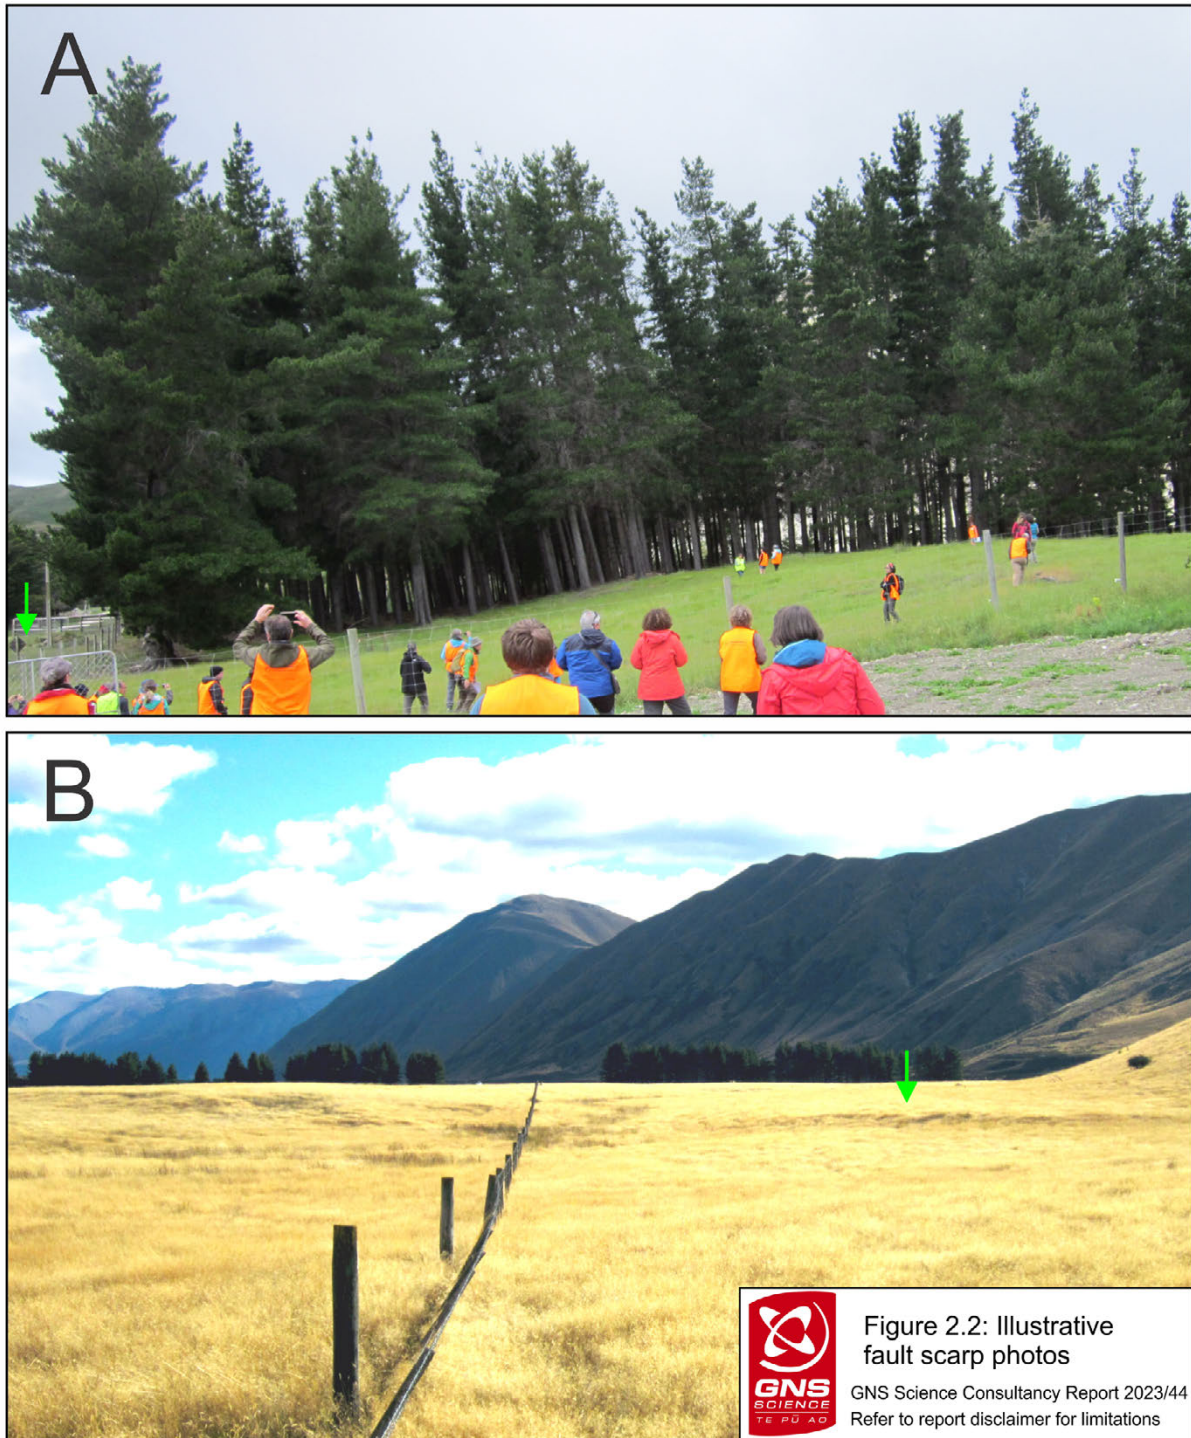
Figure 2.2 Illustrative fault scarp photos. **A:** View of a ~100-m-wide, broad fault scarp, or monoclinical fold, in the Clarence River valley, North Canterbury, formed during rupture of the Papatea Fault in the 2016 Kaikōura Earthquake (Van Dissen et al. 2019). Prior to the 2016 rupture, the ground here was flat, and was level with the road (arrowed in green). Tilting of the formerly vertical pine trees illustrates the 2016 ground deformation. Photo: DJA Barrell, November 2017. **B:** A localised fault scarp (green arrow) marking a small fault break-out associated with a broad monoclinical fold west of Twizel, South Canterbury. The ~150-m-wide monocline runs left to right across this river plain, and the fence and lower parts of the distant pine trees disappear from view beyond the crest of the fold. Subsequent trenching showed that the fault scarp is formed over a ~0.6 m near-vertical fault offset of the river plain deposits (Barrell 2019a). Photo: DJA Barrell, April 2019.

emerged at the ground surface from more focused offset on the main fault at depth (e.g. maybe 50 to 100 m below the ground surface). These zones of broad deformation may relate to warping/tilting of the ground, to incremental strain, or a combination of both. The relatively sharp fault scarp landforms have a discontinuous and somewhat arcuate character. These are interpreted as localised subsidiary faults that have broken out from the main fault at depth. Near location A in Figure 1.1, the considerable (~300 m) width of the broad fault scarp landform led me to interpret it as a monoclinal (one-sided) fold of the ground surface (Figure 1.1). The formation of broad fault scarps via distributed ground deformation in combination with localised rupture break-outs resulting in well-defined fault scarps is a demonstrated characteristic of some active faults in New Zealand, with examples shown in Figure 2.2.

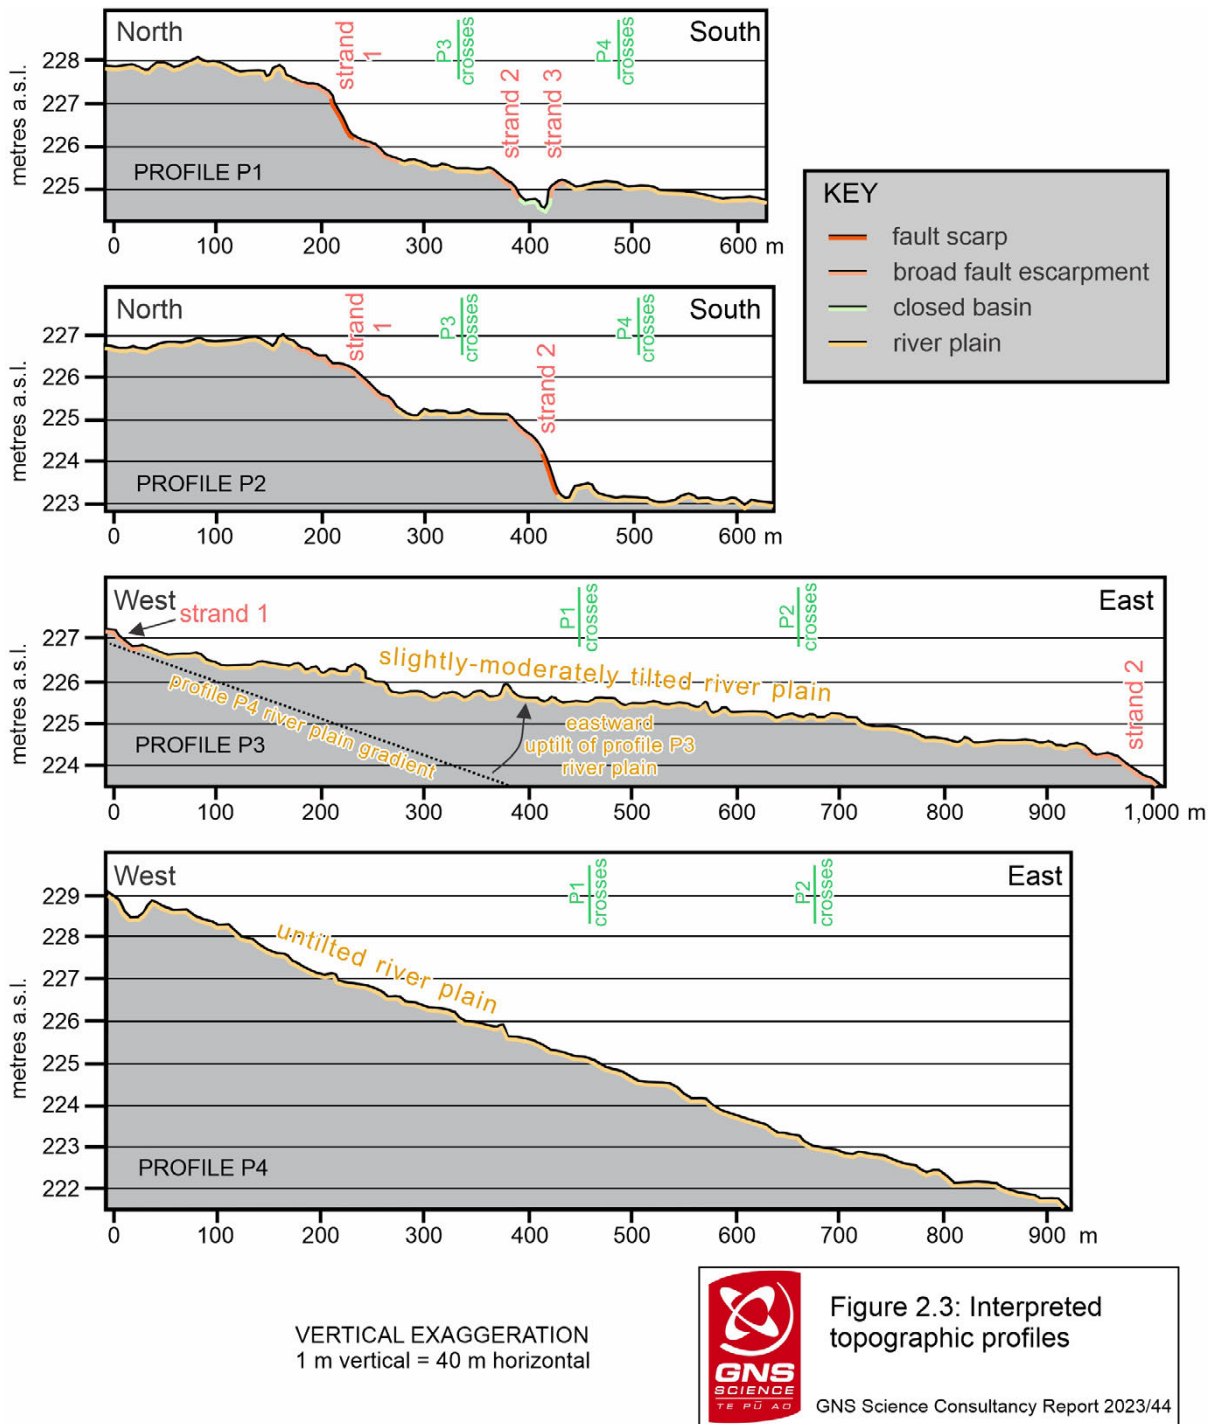
Figure 2.3 Interpreted topographic profiles. Profile locations are shown in Figure 2.1. The subsurface is shown in grey, with a black line for the ground profile. Lines below the ground profile correspond in colour to the units in the geomorphological map (Figures 1.1 and 2.1). Profile intersection locations are denoted in green. All profiles are the same scale, with the vertical dimension exaggerated 40 times relative to the horizontal scale to accentuate the subtle landform features.

To examine in closer detail the land parcel proposed for LLR zoning, four topographic profiles were generated from the lidar DEM (Figure 2.1) and are presented in Figure 2.3. The profiles together with topographic contours derived from the lidar data (see Figures 1.1 and 2.1) greatly assist in the interpretation of landform features at the location of the land parcel.

In proximity to the land parcel, the fault landforms are identified as 'strands' to aid description and discussion (Figures 2.1 and 2.3). The strand 1 fault scarp decreases in height from west to east, while the strand 2 scarp begins immediately west of the land parcel and increases in height towards the east. Strands 3 and 4 are short broad fault scarps that are up to the south. If correctly interpreted as faults, strands 3 and 4 probably represent short extensional fault features within the overall zone of the Starvation Hill Fault, as discussed further in Section 3.

The gradient of the Eyre River plain in the vicinity of the land parcel south of the Starvation Hill Fault is typical for this part of the Canterbury Plains, with a fall (elevation change in the direction of former river flow) of 1 m in about 120 m distance (Figure 2.3, profile P4). The Eyre River plain immediately south of the Starvation Hill Fault is regarded as 'untilted' and taken as representing the original natural gradient of the river plain in this area (Figures 2.1 and 2.3). The section of river plain at the land parcel between fault strands 1 and 2 is anomalously flat, with a fall of 1 m in about 460 m distance. This is difficult, though not impossible, to reconcile as being a natural river gradient on this part of the Canterbury Plains, and instead provides further indication that the ground here has been affected by fault-related deformation. It is identified as 'slightly-moderately tilted river plain' in Figure 2.1 and illustrated in profile P3 (Figure 2.3). The Eyre River plain immediately north of the Starvation Hill Fault falls at 1 m per 180 m and is interpreted as 'slightly tilted' (Figure 2.1).

Drawing together the information above, the landform history in the vicinity of the land parcel can be summarised as follows. During the Last Glaciation (approximately between 65,000 and 18,000 years ago), rivers of the Canterbury Plains, including the Eyre River, had wide-ranging courses across the plains (Barrell et al. 2011a). The glacial episode ended about 18,000 years ago, with rapid warming of climate (Denton et al. 2021). The climatic improvement reduced the river sediment load, with most rivers adopting more stable courses, incised slightly below the main surface of the plains. On this basis, 18,000 years ago is adopted as the time when river action ceased across much of the plains (Barrell and Begg 2013). Since then, movement on the Starvation Hill Fault has deformed the surface of the Eyre River plain. The vertical component of deformation increasing towards the east accounts for the slight tilt of the river plain north of the fault (westward tilt reducing the original eastward gradient of the plain). Emergence of the strand 2 fault, and its rapid height increase towards the east accounts for a distinct westward tilt on the river plain section between strands 1 and 2, which has reduced the original eastward gradient of the river plain to almost flat (Figures 2.1 and 2.3).
