## RE: Ecology reports for rezoning

### 2 Ashworths Road:

### 25 Ashley Gorge Road:

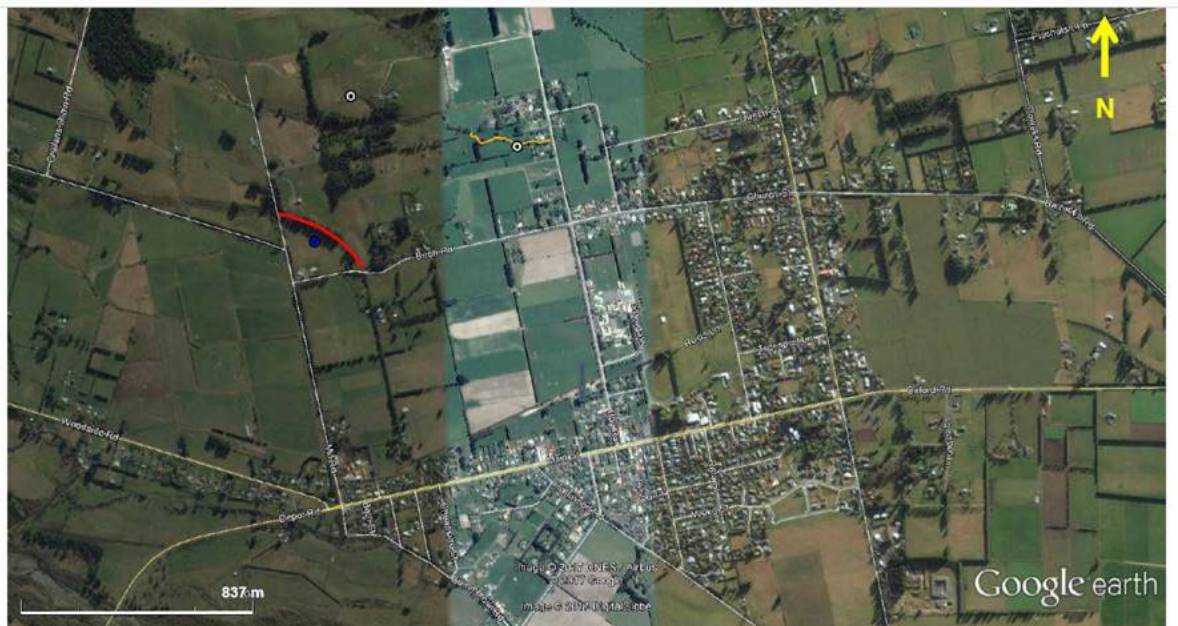
Figure ii. Canterbury mudfish records at Oxford. Canterbury mudfish records from the freshwater fish database are represented as follows: dark blue dots = pre 1950's; light blue dots = 1950- 1999; yellow dots = 2000- 2014 and red dots = 2015- 2016. AEL's 2016 search sites are represented by white dots and no canterbury mudfish were found. Orange lines = WDC open drains and red lines = open drains to be cleaned.

- 6) No historic mudfish records are in the NZ Freshwater Fish Database for this area. Here's a summary map in an AEL report from TRIM 180326031997 for that area:
