WAIMAKARIRI DISTRICT COUNCIL
HISTORIC HERITAGE ITEM RECORD FORM

2021 District Plan Item No. HH064

HERITAGE ITEM NAME former Bank of New Zealand manager's residence / Rangiora Museum

ADDRESS 29 Good Street, Rangiora

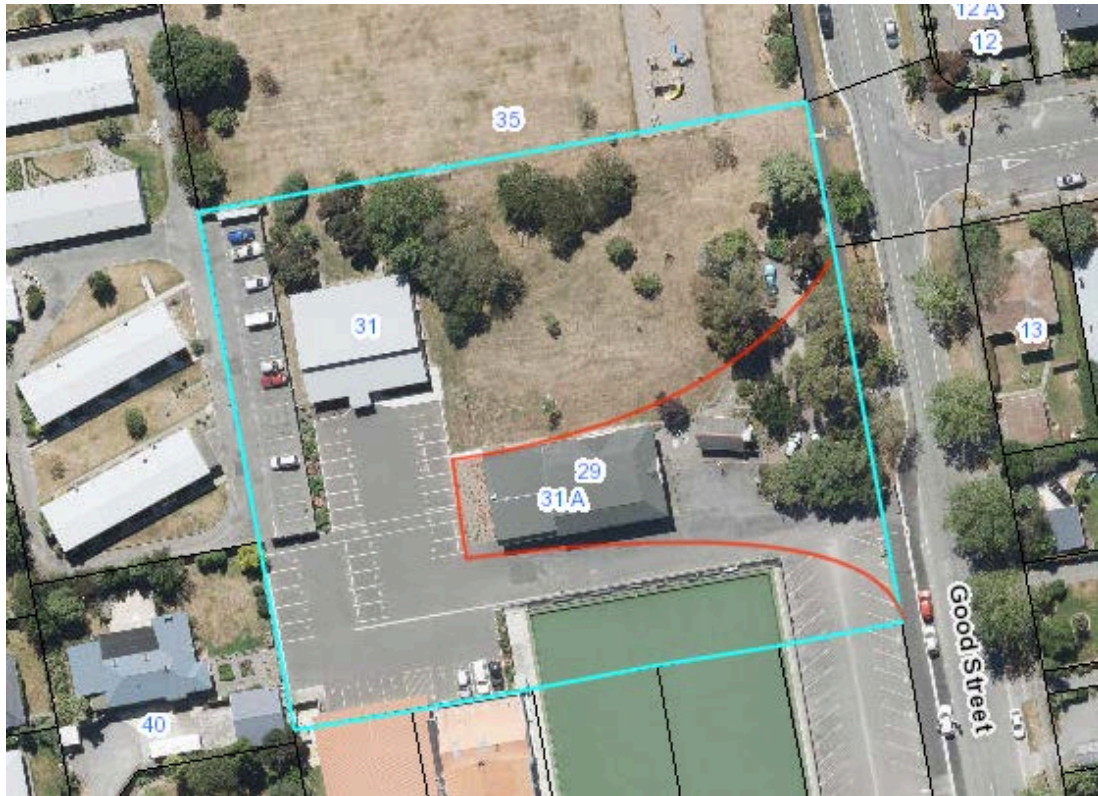
Extent of setting, limited to that part of the site on which the building is located and maintaining sightlines from the public domain, former BNZ manger's residence / Rangiora Museum, 29 Good Street, Rangiora.

The building stands on the southern portion of the Good Street Reserve, north of the Rangiora Bowling Club. Good Street borders the reserve to the east and Blckett Street is to the south. The museum stands close to a replica cob cottage and is partially screened from the road by trees and shrubs. The extent of scheduling is limited to that portion of the land parcel on which the building is located and is intended to protect sightlines from the roadway.
